Expertise

Protocol number: 46641427  
Order No. / Reference: 26716594  
Inspection date: 21 Jul 2026

Manufacturer: Mercedes-Benz

Model: E 220 d T 9G-TRONIC

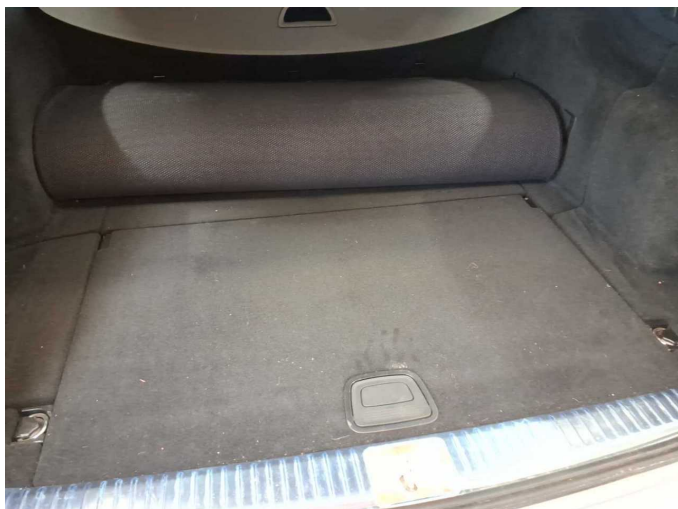
**Figure 42: Misc.**

**Damage 1:** Rear of vehicle: Boot floor (Verkleidung) - Broken / torn - Replace
