Expertise

Protocol number: 46583987  
Order No. / Reference: 26701496  
Inspection date: 16 Jul 2026

Manufacturer: Skoda  
VIN: TMBJH7NP0M7072616

Model: Superb Combi 2.0 TDI Style

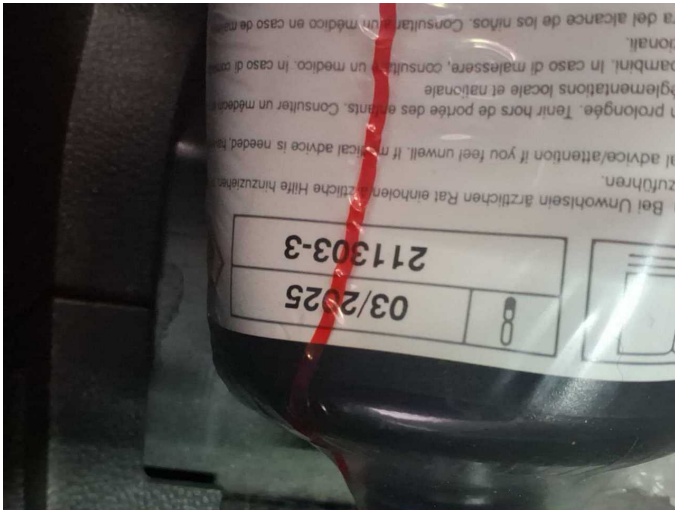
| No. | Component group | Description |
|---|---|---|
| 4 | Equipment | Tirefit filler - Expired - Replace |

Damage 4: Equipment: Tirefit filler - Expired - Replace

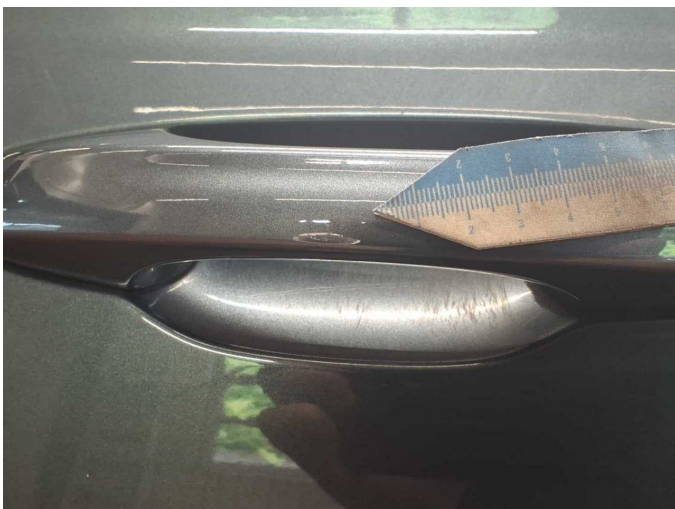
| No. | Component group | Description |
|---|---|---|
| 5 | Door - front left side | Door handle - outside - Scratch(es) - Smart repair |

Damage 5: Door - front left side: Door handle - outside - Scratch(es) - Smart repair

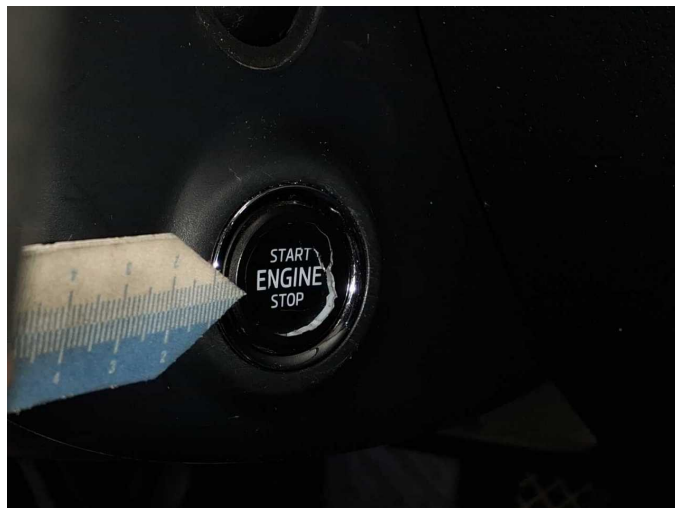
| No. | Component group | Description |
|---|---|---|
| 8 | Steering system | Steering column (Taster Startknopf) - Broken / torn - Loss in value |

**Damage 8:** Steering system: Steering column (Taster Startknopf) - Broken / torn - Loss in value

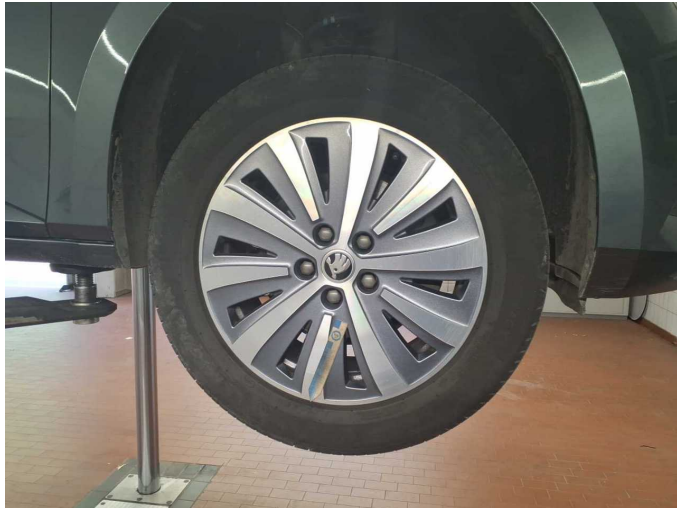
| No. | Component group | Description |
|---|---|---|
| 14 | Wheel / tyres | Tyre - front right side (nicht fahrbereit) - Broken / torn - Replace |

**Damage 14:** Wheel / tyres: Tyre - front right side (nicht fahrbereit) - Broken / torn - Replace

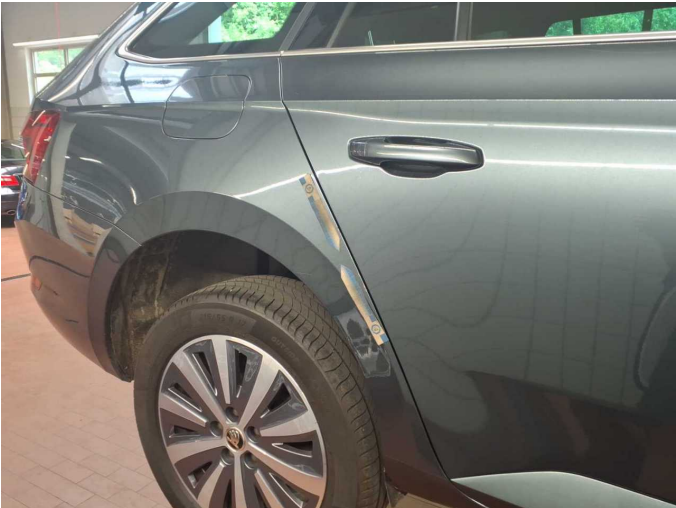
Damage 17: Side panel - rear right side: Side panel - Scratch(es) - Paint

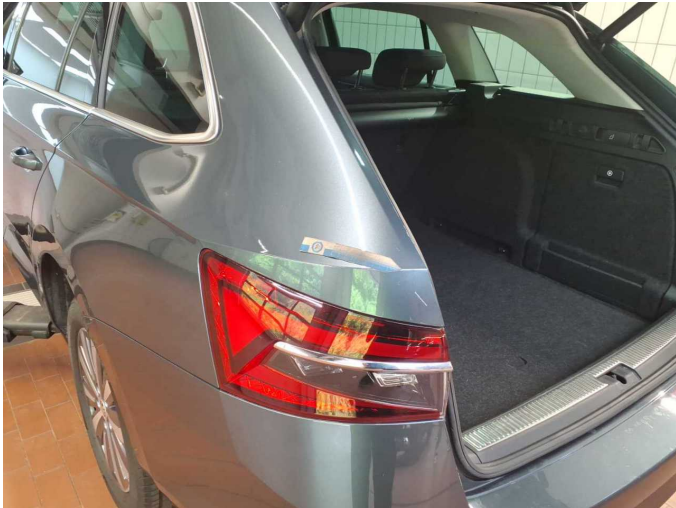
**Damage 19:** Side panel - rear left side: Side panel - Dent / paintcoat damage - Repair and paint

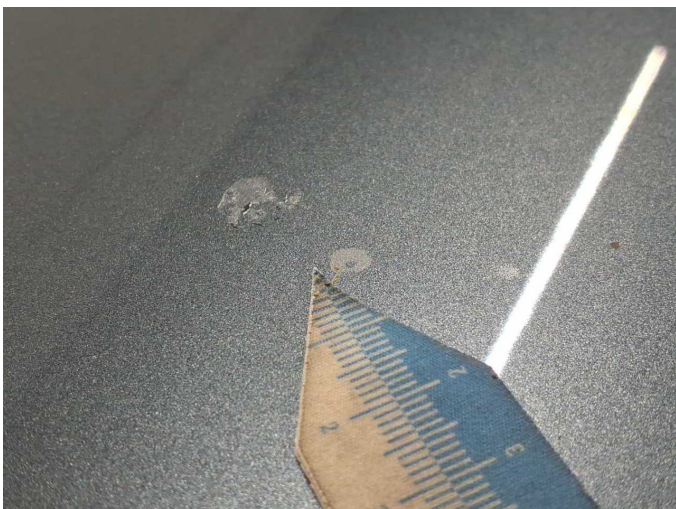
**Damage 20:** Bonnet: Bonnet (+ Steinschläge) - Paint defect - Paint

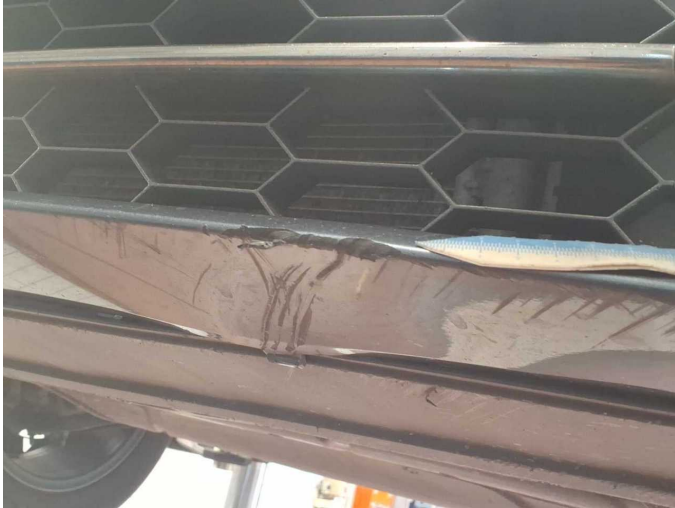
**Damage 21:** Front bumper: Front bumper (+ Fehlstellung) - Scratched - Repair and paint

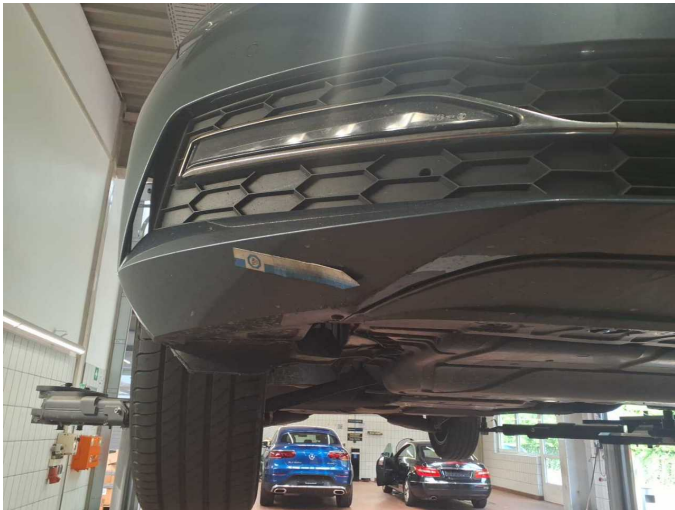
**Damage 21:** Front bumper: Front bumper (+ Fehlstellung) - Scratched - Repair and paint

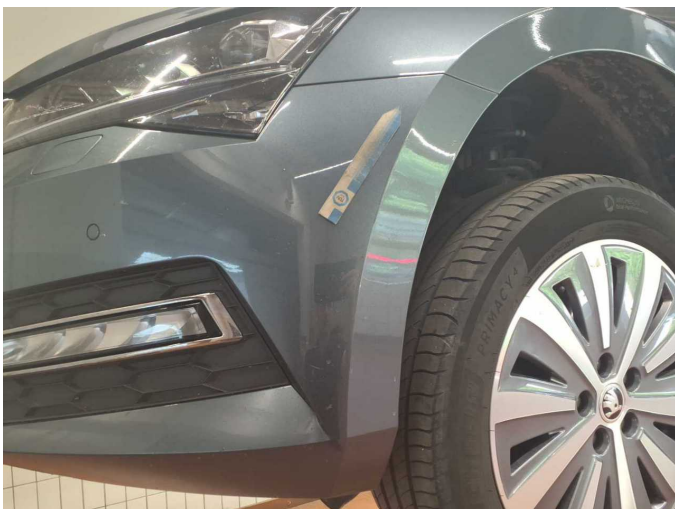
**Damage 21:** Front bumper: Front bumper (+ Fehlstellung) - Scratched - Repair and paint

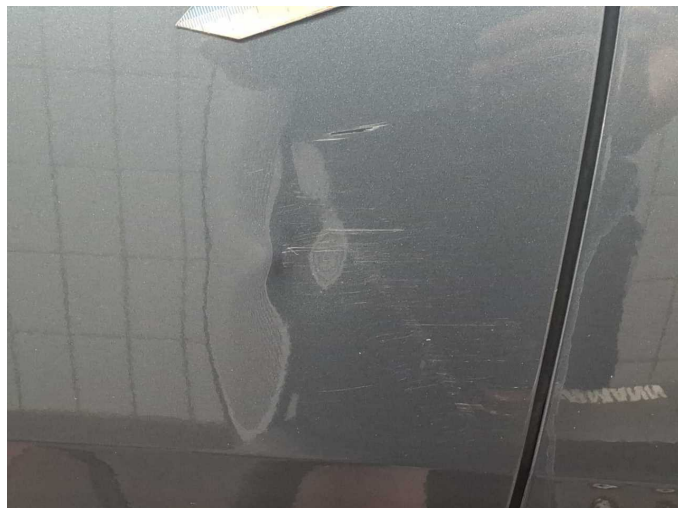
**Damage 22:** Door - rear right side: Door (+ Zierleiste verschürft - lackieren) - Dent / paintcoat damage - Repair and paint

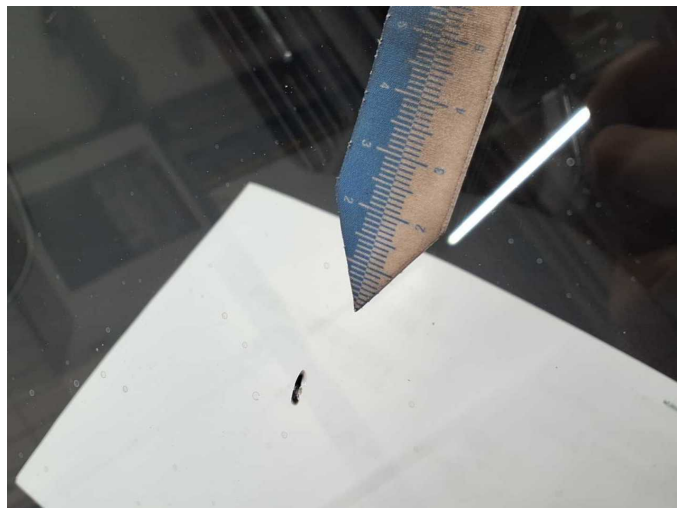
**Damage 23:** Vehicle glazing: Windscreen (Im Sichtbereich) - Stone chips - Replace

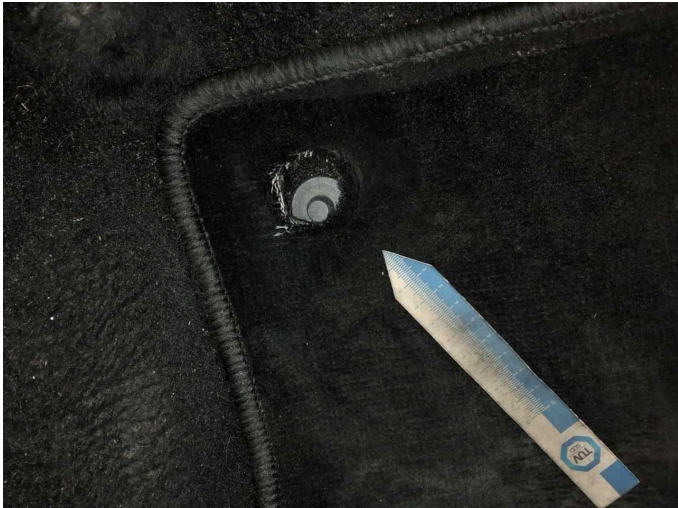
**Wear and tear 5:** Trim / covers: Floor mats - Broken / torn - No deduction

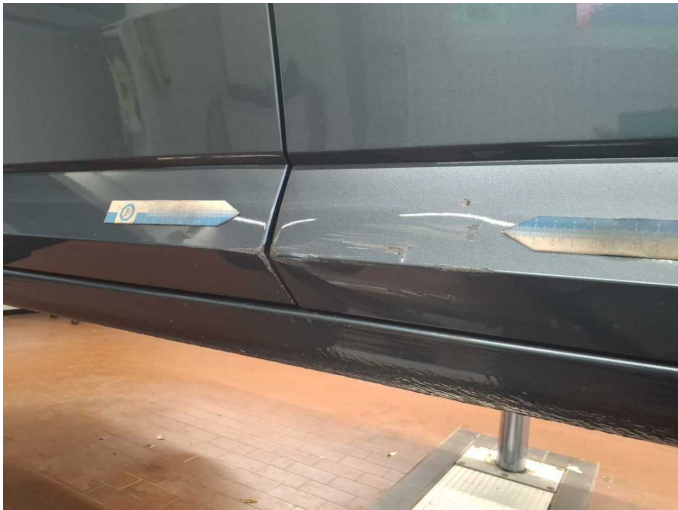
**Accident 1:** Side - left

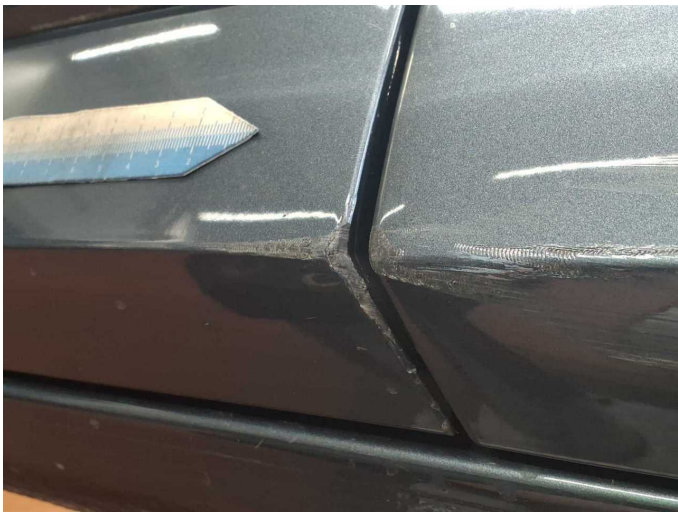
**Accident 1:** Side - left

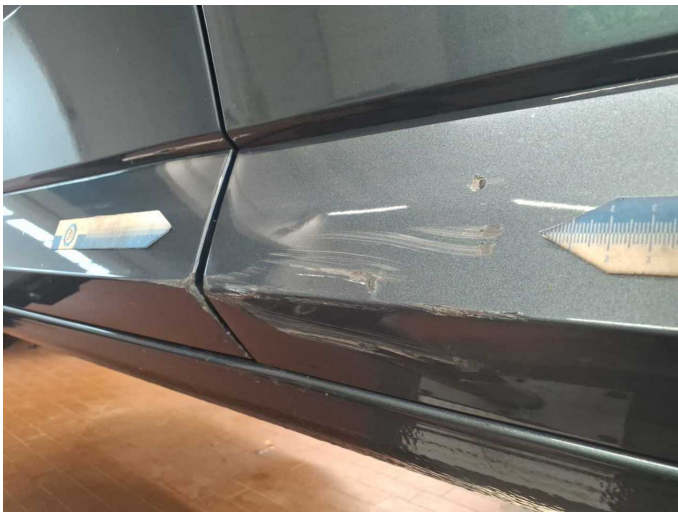
**Accident 1:** Side - left
