Expertise

Protocol number: 46680249  
Order No. / Reference: 26585299  
Inspection date: 15 Jul 2026

Manufacturer: Volkswagen

Model: Crafter 35 TDI 4MOTION Trendline

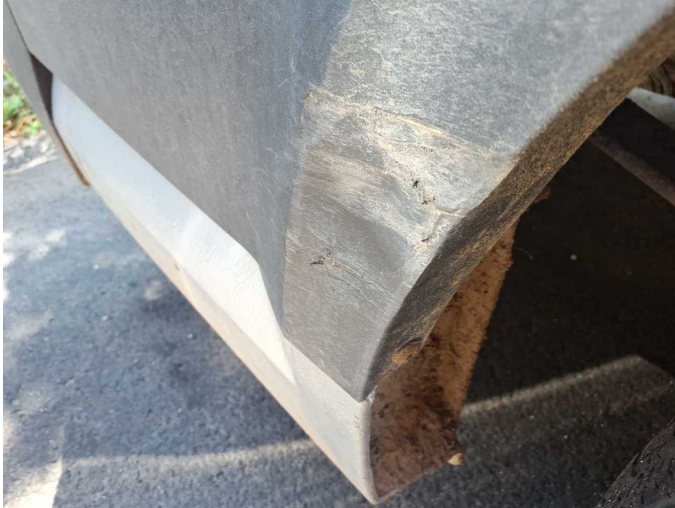
**Accident 1: Side right**

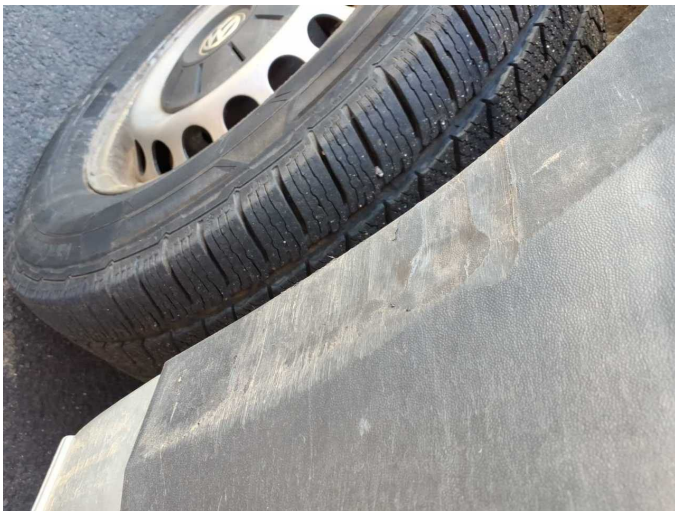
**Accident 1: Side right**

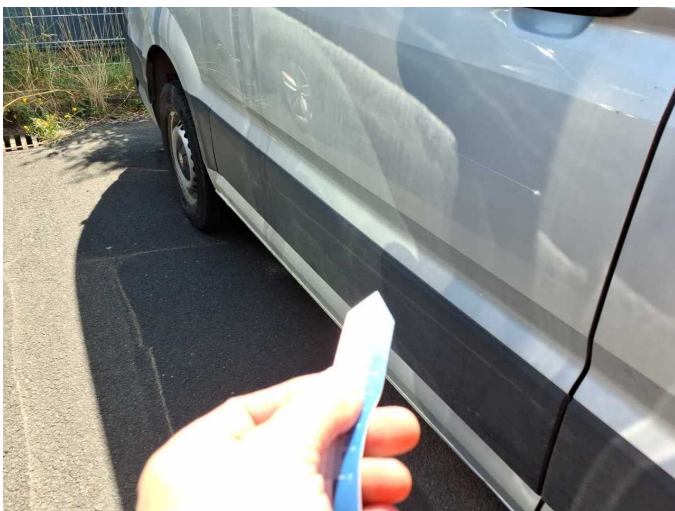
**Accident 1: Side right**
