Expertise

Protocol number: 46114796
Order No. / Reference: 26541759
Inspection date: 24 Jun 2026

Model: Octavia Combi 2.0 TDI DSG Sportline

VIN: TMBJJ8NX5PY038633

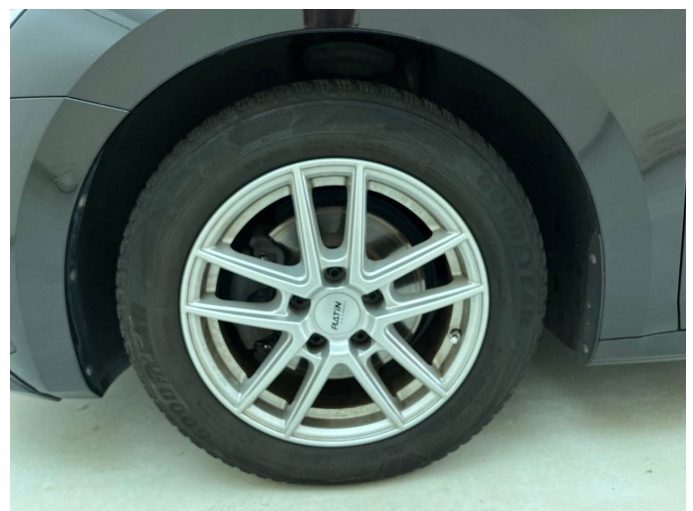
Figure 12: Mounted tyres

Mounted tyres				
#	Tyre size	Type of tyre	Manufacturer	Tread depth
1)	205/60 R16 92H	Winter tyres on Light alloy	Goodyear	3mm / 2mm
2)	205/60 R16 92H	Winter tyres on Light alloy	Goodyear	5mm / 5mm

- Für den montierten Radsatz wurde kein Nachweis erbracht.
- Winterradsatz ist kein Bestandteil des Auslieferungsumfangs.

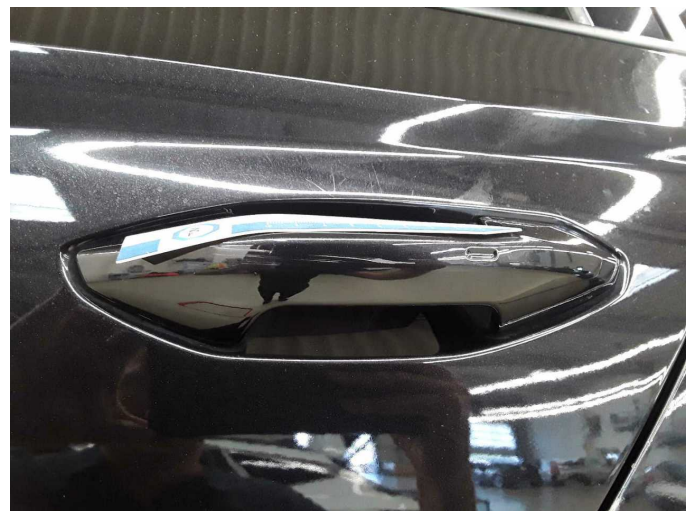
Damage 1: Door - rear left side: Door handle - outside - Scratched - Smart repair

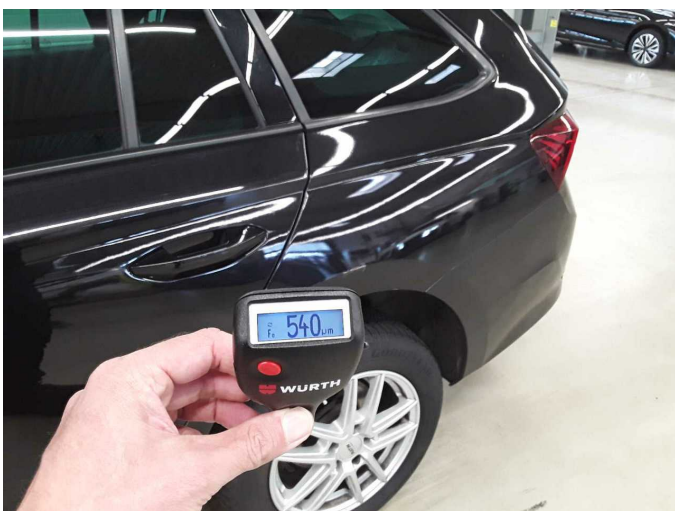
Side panel - rear left side: 3,050 μm
