## Expertise

Protocol number: 46292724  
Order No. / Reference: 26512448  
Inspection date: 1 Jul 2026

Manufacturer: Ford

Model: Mondeo Turnier 2.0 EcoBlue Titanium

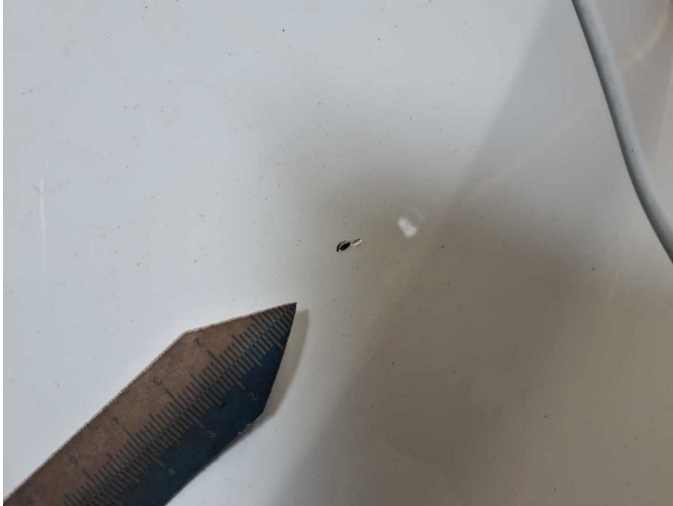
**Damage 6:** Boot lid / rear door: Boot lid - Scratch(es) - Smart repair

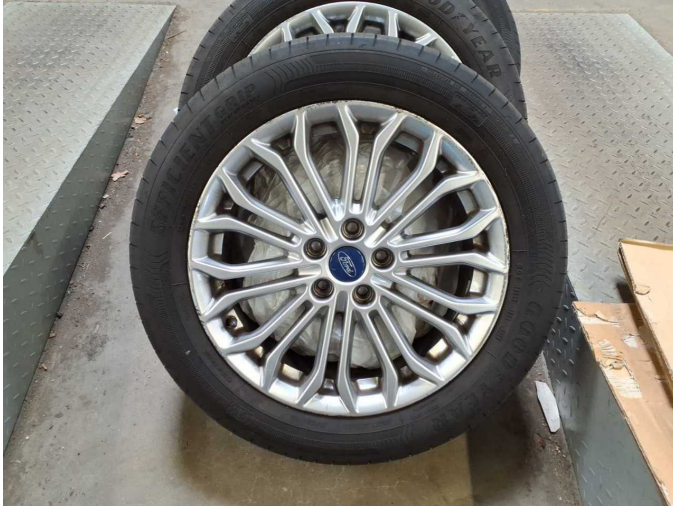
**Damage 9:** 2nd wheel set: 1 alloy rim - Scratched - Loss in value

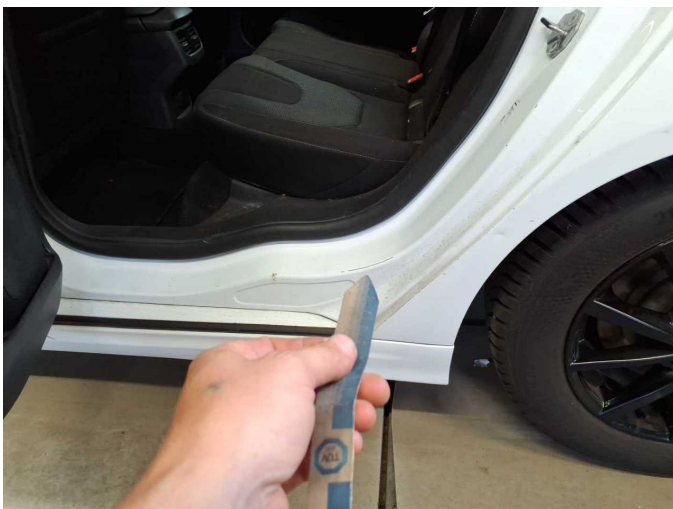
**Damage 18:** Side panel - rear left side: Side panel - Dent / paintcoat damage - Repair and paint

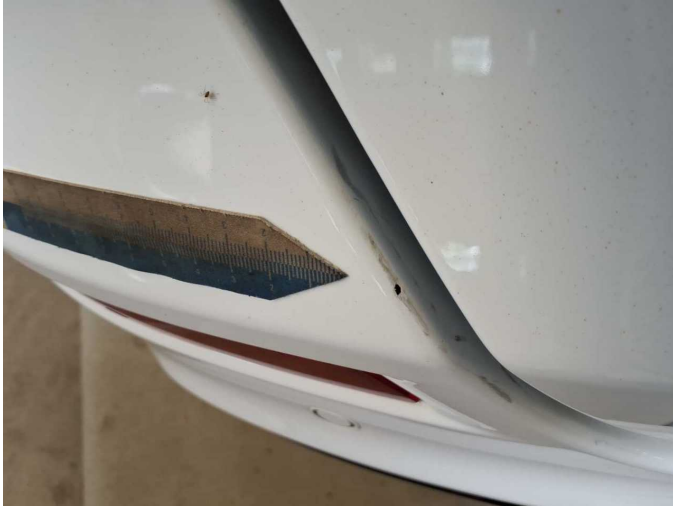
**Damage 20:** Rear bumper: Rear bumper - Scratched - Paint

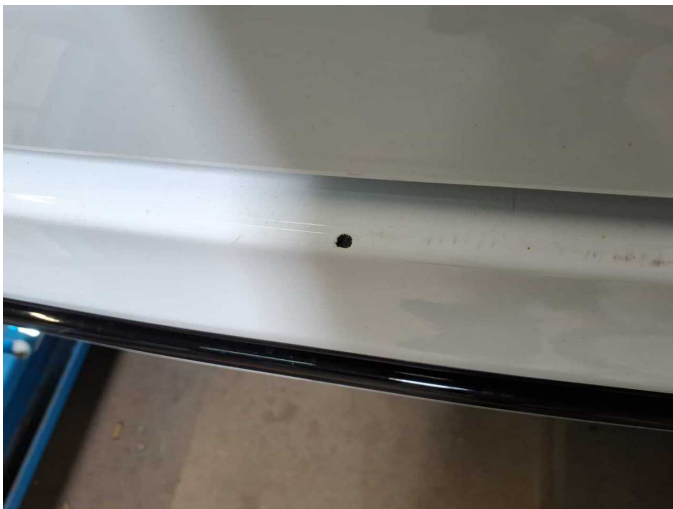
**Damage 20:** Rear bumper: Rear bumper - Scratched - Paint

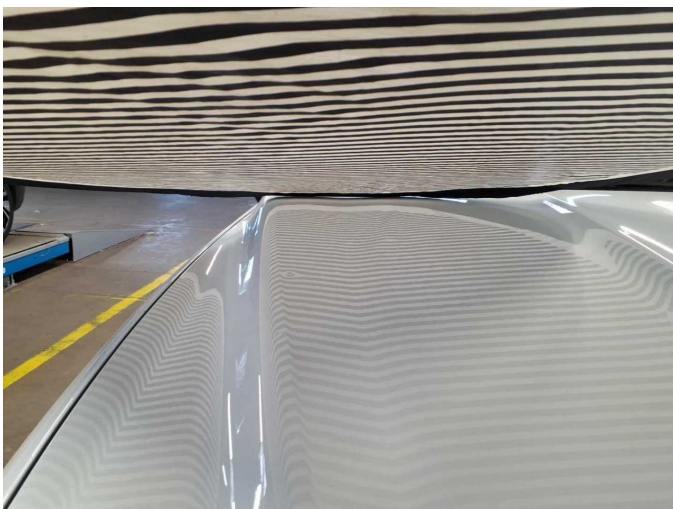
**Damage 21:** Body: Body (+ Motorhaube Lackschaden) - Damage by hail - Smooth repair work

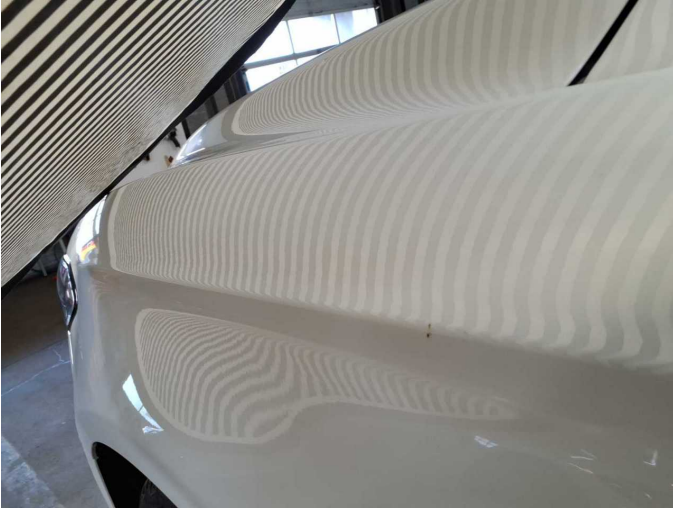
**Damage 21:** Body: Body (+ Motorhaube Lackschaden) - Damage by hail  
- Smooth repair work

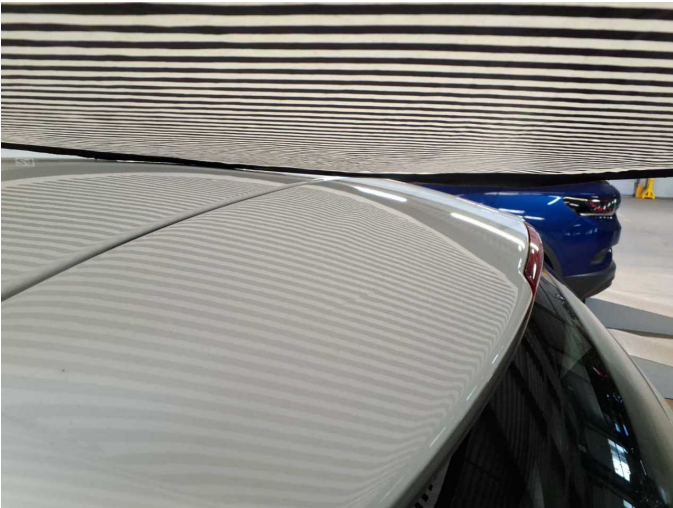
**Damage 21:** Body: Body (+ Motorhaube Lackschaden) - Damage by hail  
- Smooth repair work
