Expertise

Protocol number: 46750649  
Order No. / Reference: 26628879  
Inspection date: 28 Jul 2026

Manufacturer: Opel

Model: Zafira Life 2.0 D L Aut. Elegance

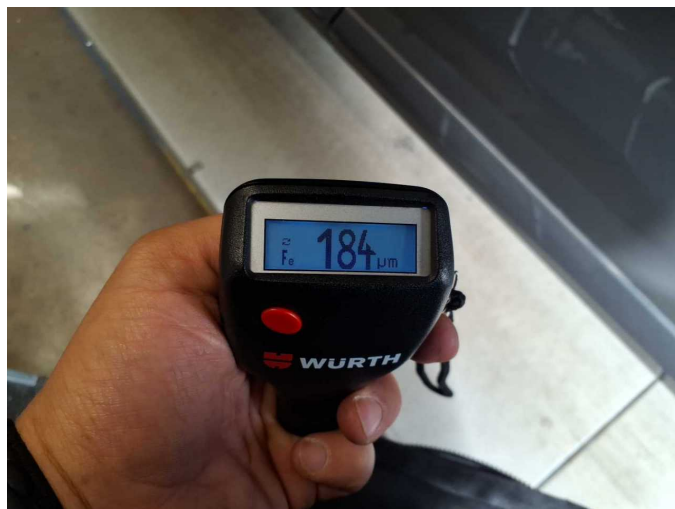
**Repainting 1:** Roof, Door - rear right side, Door - front right side
