Expertise

Protocol number: 46811409  
Order No. / Reference: 26746485  
Inspection date: 30 Jul 2026

Manufacturer: Skoda  
VIN: TMBJH7NP4N7041483

Model: Superb Combi 2.0 TDI DSG Ambition

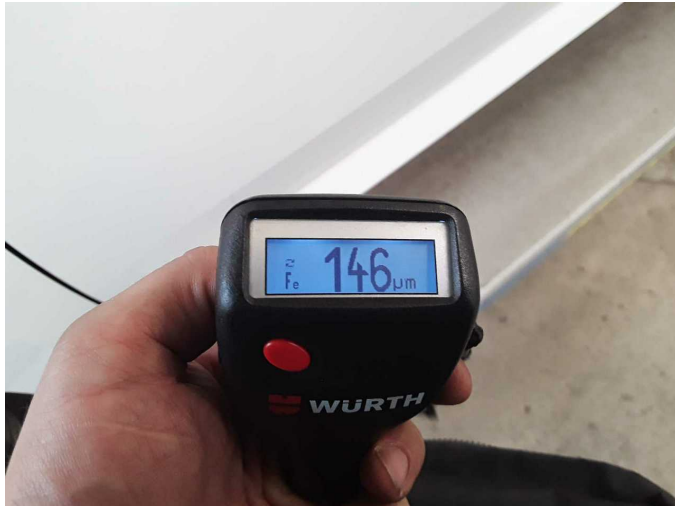
**Repainting 1:** Mudguard - left side, Door - front left side
