Expertise

Protocol number: 46202180
Order No. / Reference: 26544865
Inspection date: 26 Jun 2026

Manufacturer: Ford

Model: Transit Connect 250 L2 Trend

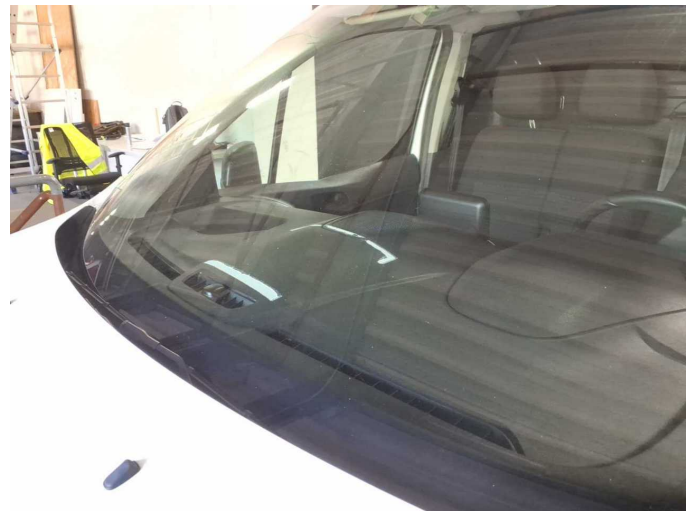
Damage 1: Instrument panel: Centre console - front - Glued / labelled - De-glue / neutralise
