## Expertise

Protocol number: 45444541  
Order No. / Reference: 26173256  
Inspection date: 12 May 2026

Model: Proace 2,0-I-D-4D L1 (9-Si.) Comfort

VIN: YARVEEHTMGZ210130

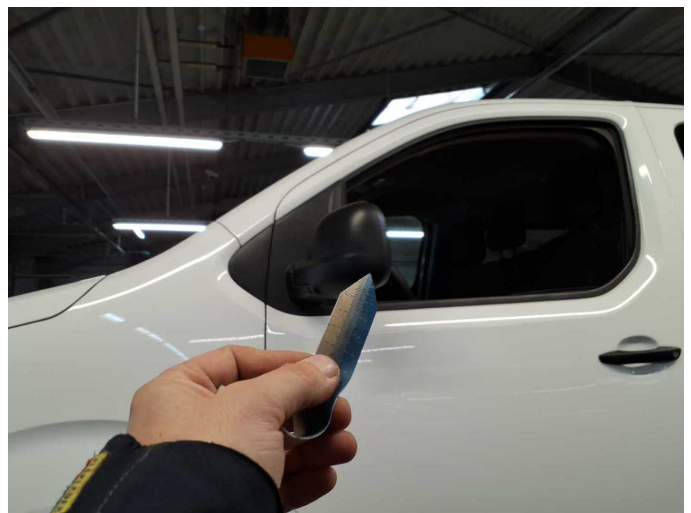
Damage 1: Wing mirror - left side: Cap - Scratched - Replace
