Expertise

Protocol number: 46605981  
Order No. / Reference: 26701943  
Inspection date: 20 Jul 2026

Manufacturer: Volkswagen  
VIN: WVGZZCD1PW513507

Model: Golf Variant 2.0 TDI SCR DSG Style

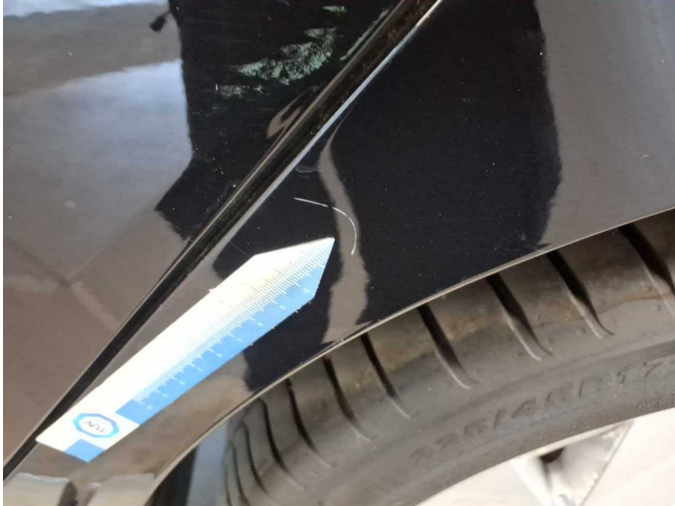
| No. | Component group | Description |
|---|---|---|
| 11 | Side panel - rear left side | Side panel - Scratch(es) - Smart repair |

**Damage 11:** Side panel - rear left side: Side panel - Scratch(es) - Smart repair

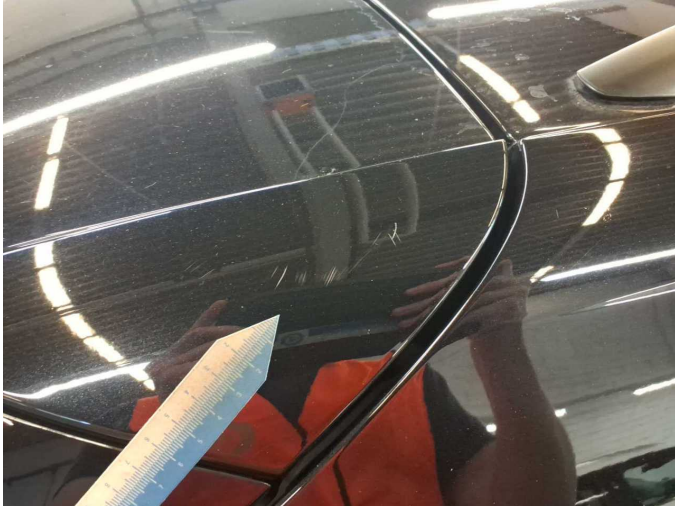
**Damage 13:** Boot lid / rear door: Boot lid - Scratch(es) - Paint

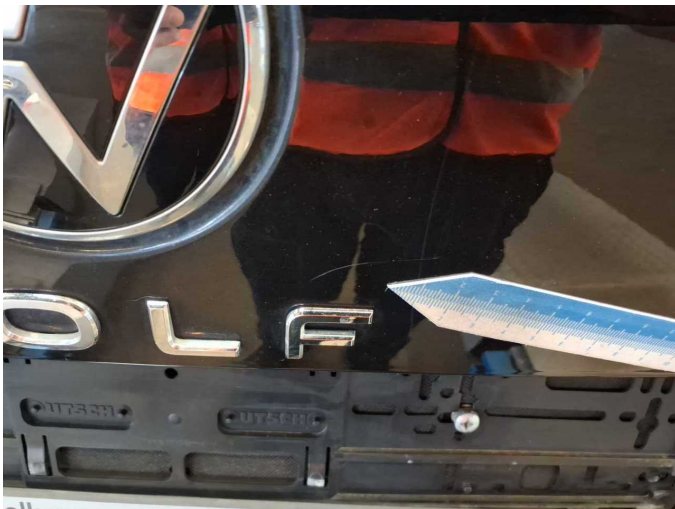
**Damage 14:** Boot lid / rear door: Boot lid - Scratch(es) - Paint

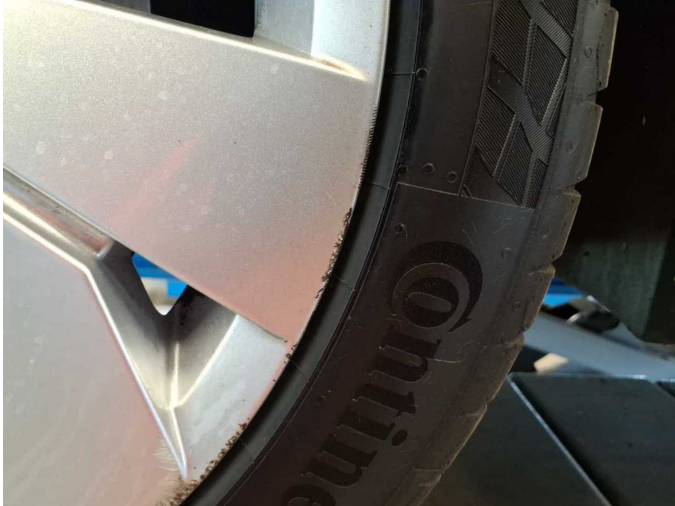
**Damage 15:** Wheel / tyres: Alloy rim - front left side - Scratch(es) - Replace

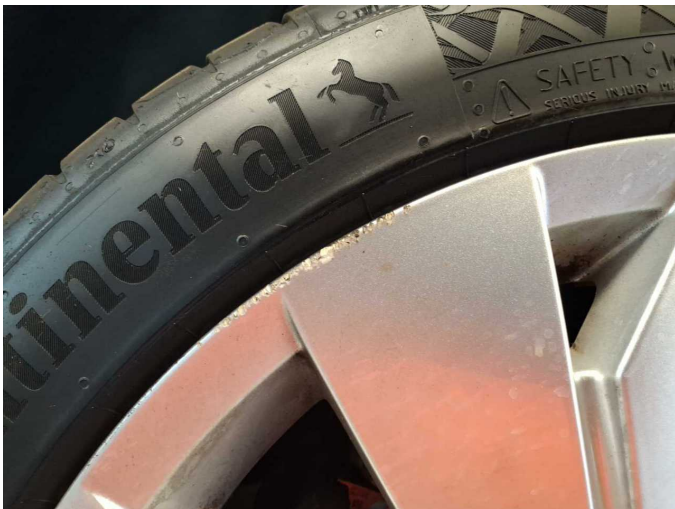
**Damage 15:** Wheel / tyres: Alloy rim - front left side - Scratch(es) - Replace

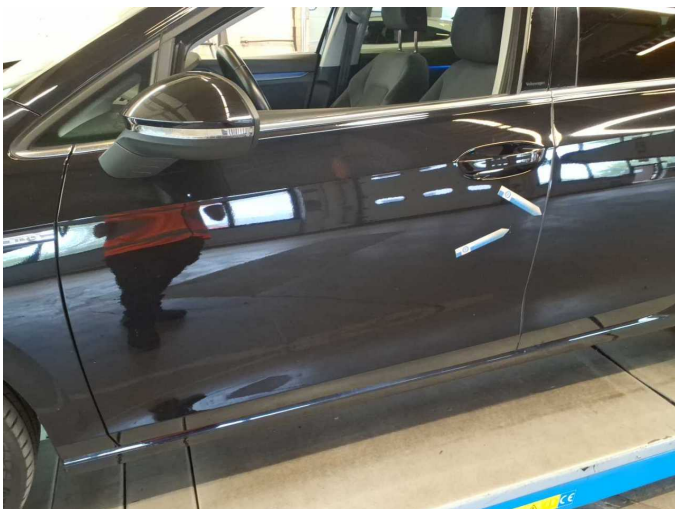
**Damage 16:** Door - front left side: Door - Scratch(es) - Paint

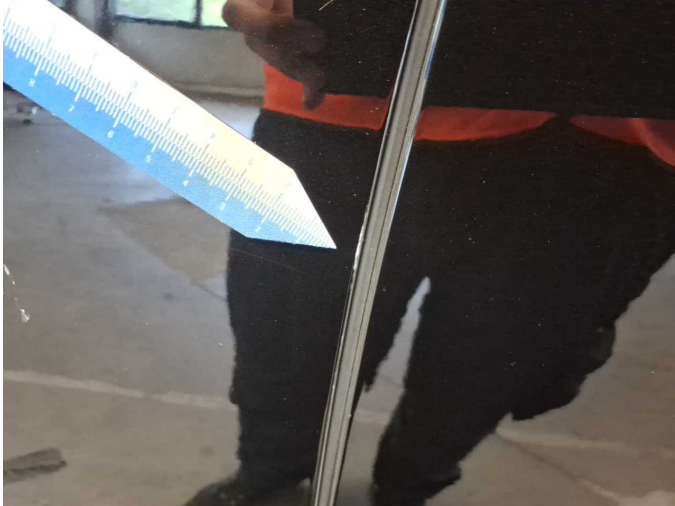
**Damage 16:** Door - front left side: Door - Scratch(es) - Paint

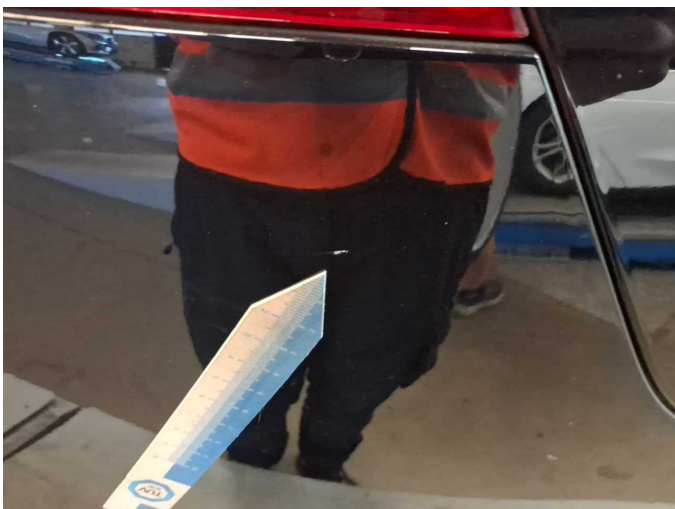
**Damage 17:** Rear bumper: Rear bumper - Scratch(es) - Paint

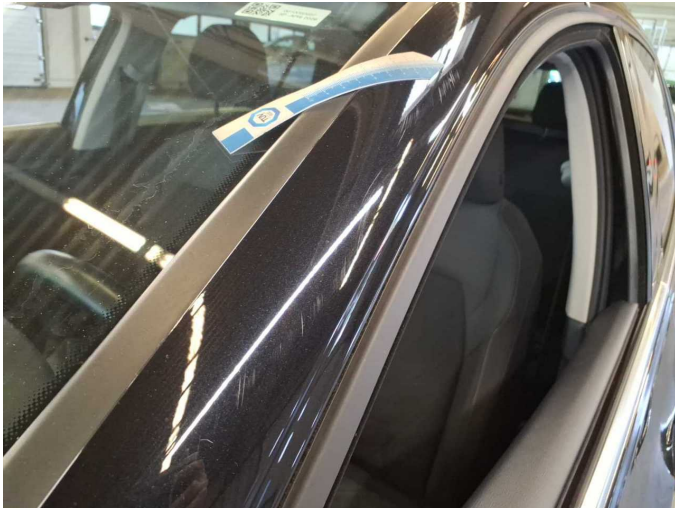
**Damage 18:** Roof: Roof rail - left side - Scratch(es) - Paint

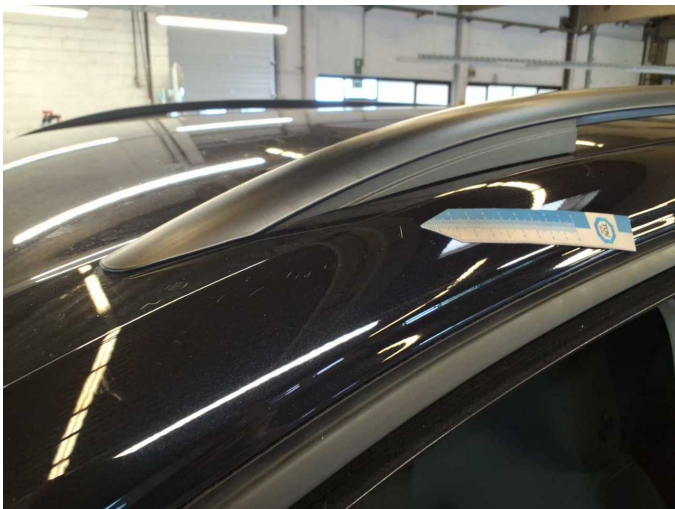
**Damage 18:** Roof: Roof rail - left side - Scratch(es) - Paint

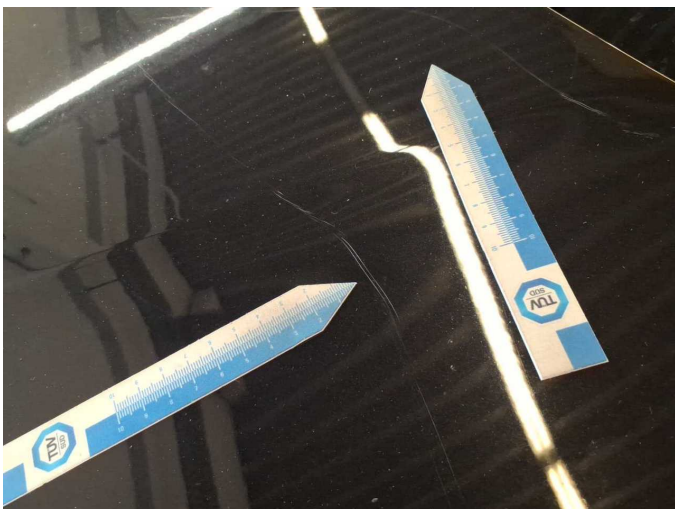
**Damage 19:** Bonnet: Bonnet - Scratch(es) - Paint

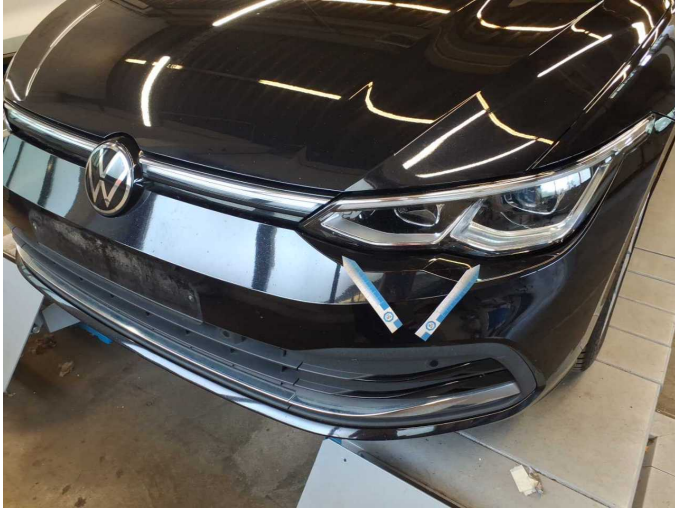
**Damage 19:** Bonnet: Bonnet - Scratch(es) - Paint

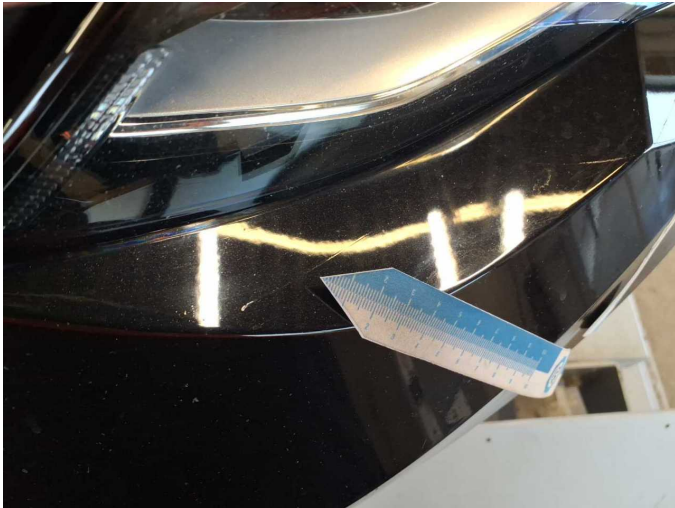
**Damage 20:** Front bumper: Front bumper (+ Steinschläge) - Scratch(es) - Paint

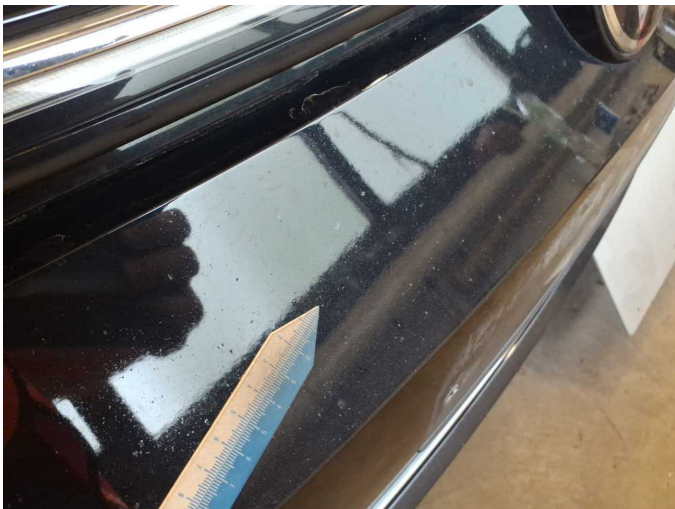
**Damage 20:** Front bumper: Front bumper (+ Steinschläge) - Scratch(es) - Paint

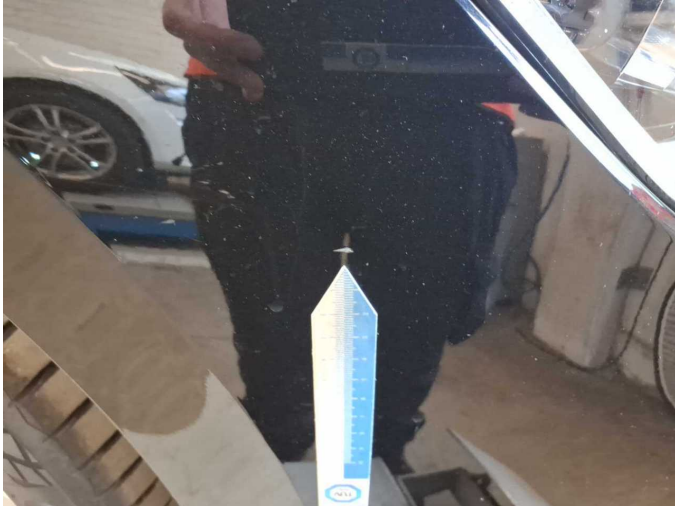
**Damage 20:** Front bumper: Front bumper (+ Steinschläge) - Scratch(es) - Paint

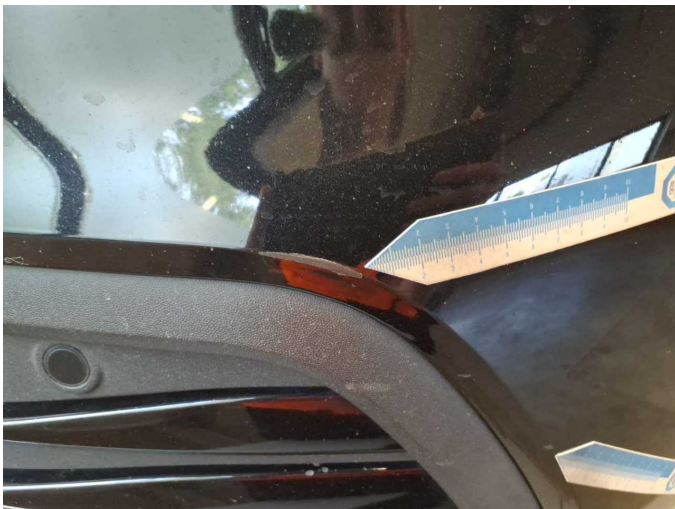
**Damage 20:** Front bumper: Front bumper (+ Steinschläge) - Scratch(es) - Paint

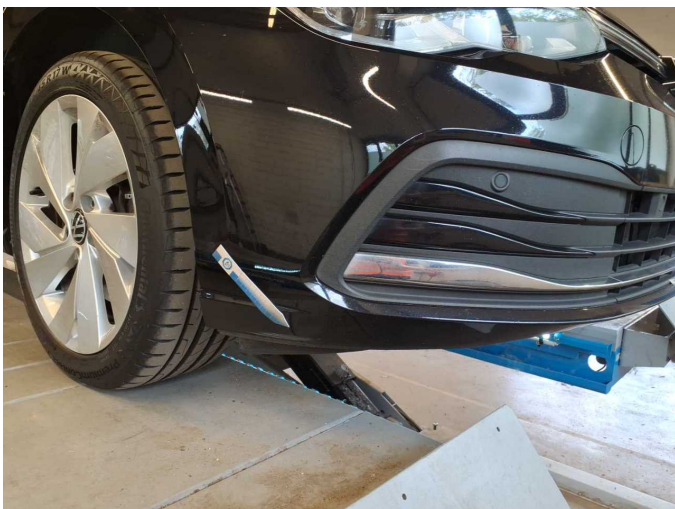
**Damage 20:** Front bumper: Front bumper (+ Steinschläge) - Scratch(es) - Paint
