Expertise

Protocol number: 46231795
Order No. / Reference: 26510637
Inspection date: 25 Jun 2026

Manufacturer: Ford

Model: Mondeo Turnier 2.0 EcoBlue Titanium

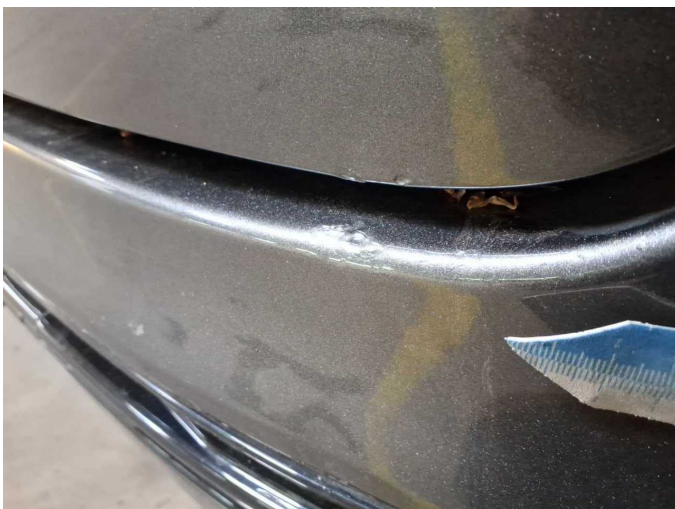
Accident 1: Rear

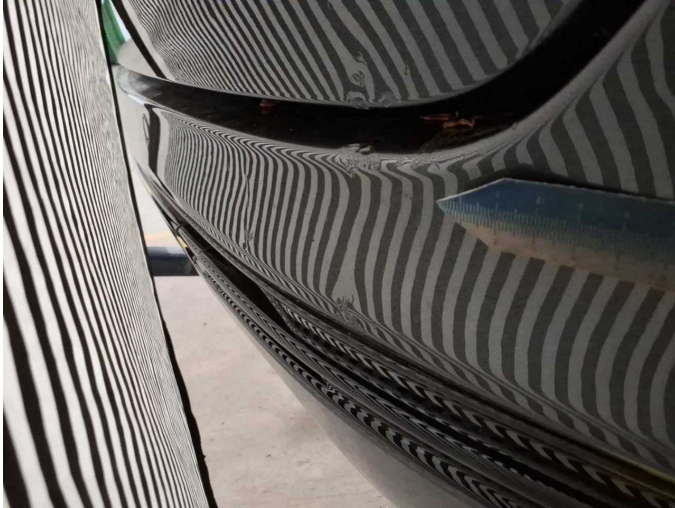
Accident 1: Rear

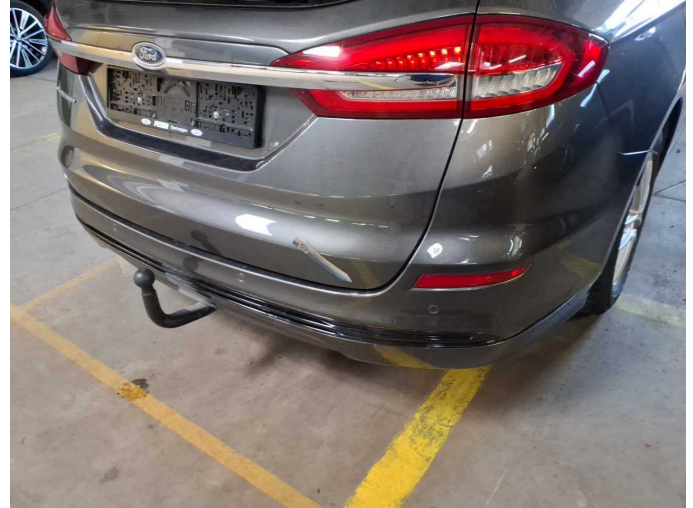
Accident 1: Rear

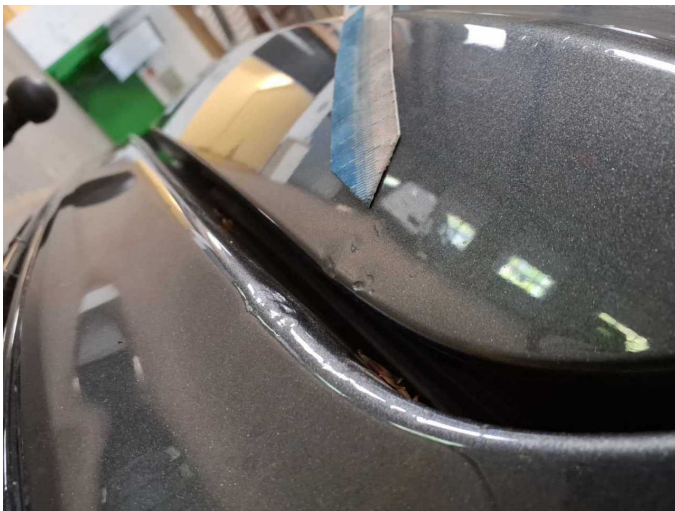
Accident 1: Rear

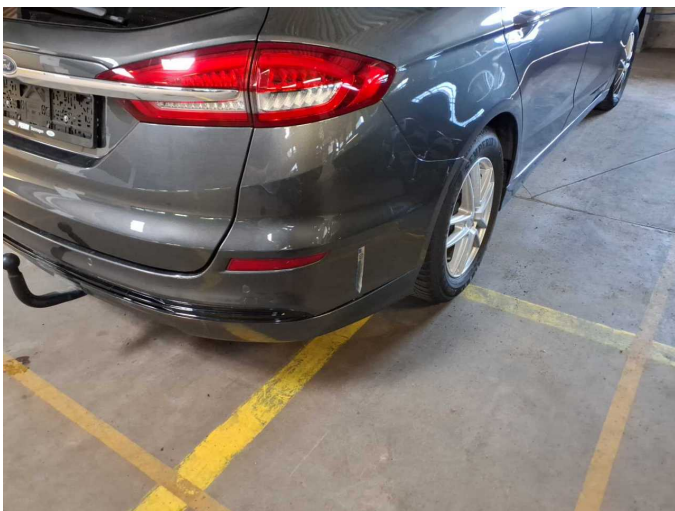
Accident 1: Rear

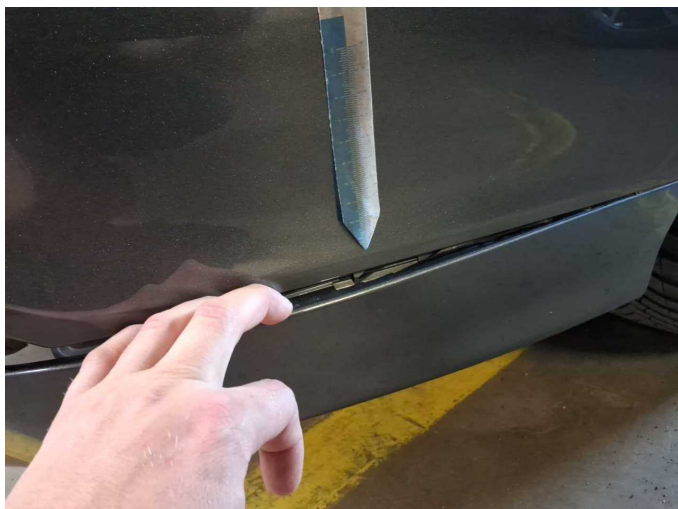
Accident 1: Rear

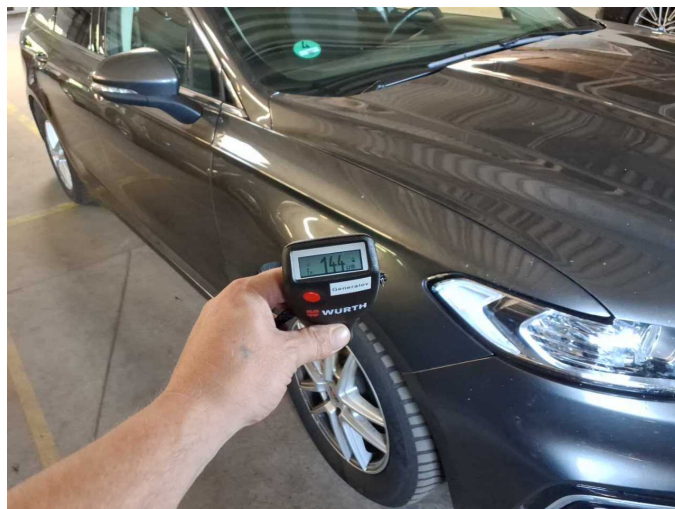
1 Mudguard - right side, Professionally carried out, Invoice of repair done Non-existent

Repainting 1: Mudguard - right side
