Expertise

Protocol number: 46181937
Order No. / Reference: 26242175
Inspection date: 25 Jun 2026

Model: Tiguan Allspace 2.0 TDI SCR Comfortline

VIN: WVGZZZ5NZLM160478

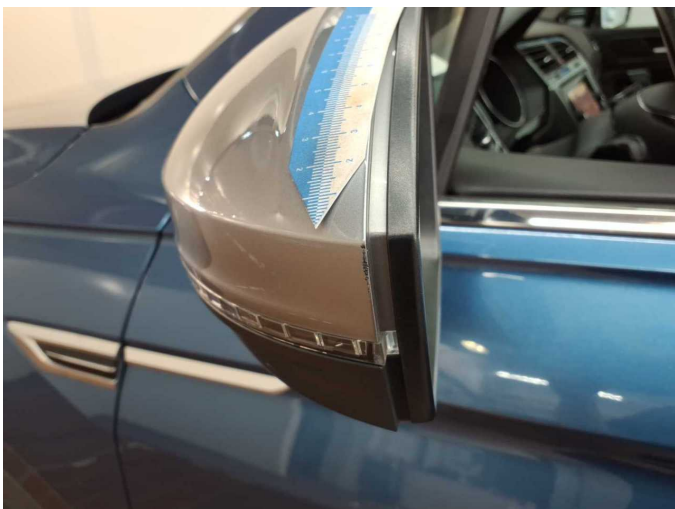
Damage 2: Wing mirror - left side: Cap - Scratch(es) - Smart repair

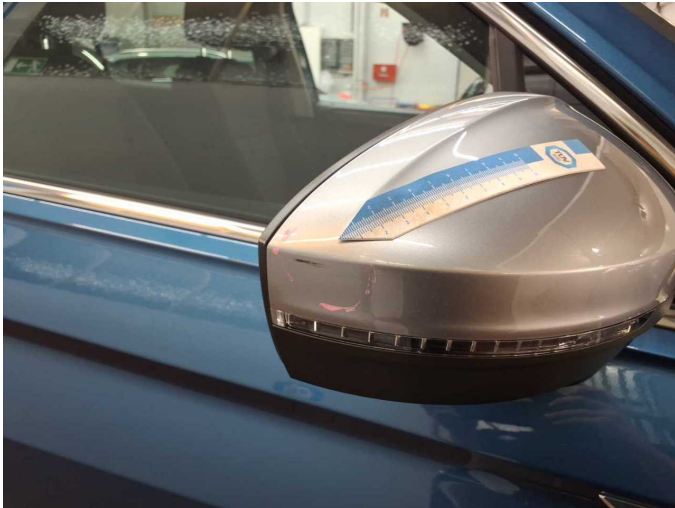
Damage 3: Wing mirror - right side: Cap - Scratch(es) - Smart repair

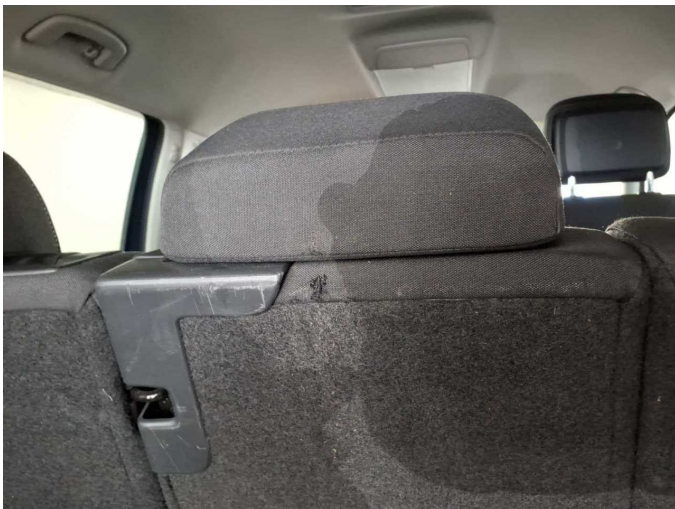
Damage 4: Seat - rear: Back seat - Holes - Smart repair

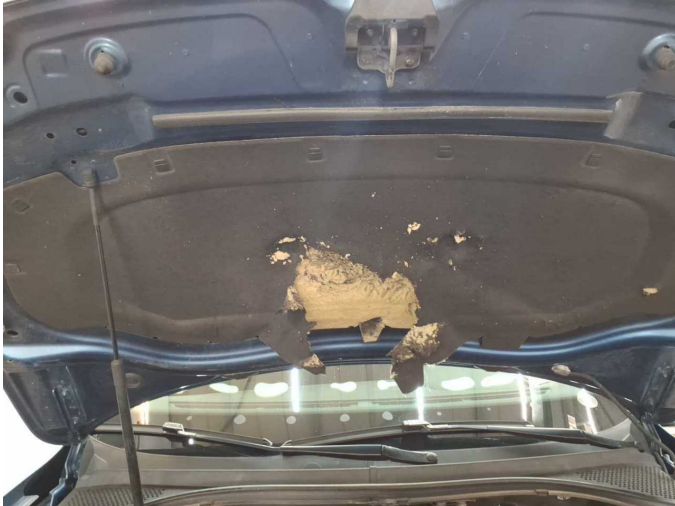
Marder Spuren sind im Motorraum, weitere Schäden sind möglich.

Damage 6: Bonnet: Insulation lining - Damage caused by marten / rodent
- Replace

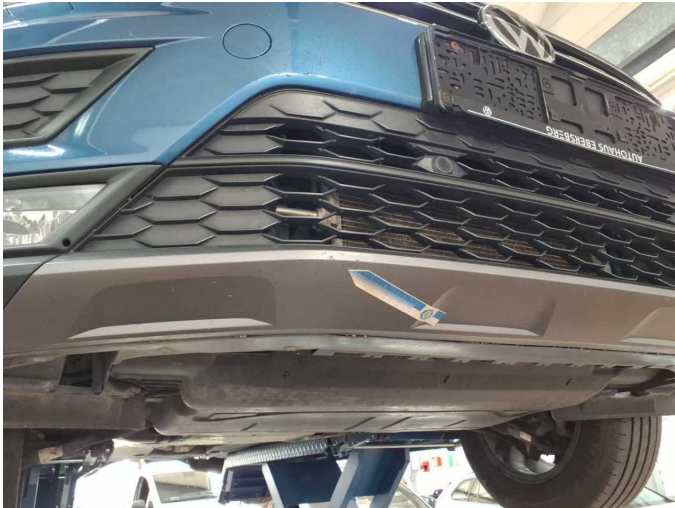
Damage 11: Front bumper: Spoiler - Scratch(es) - Paint

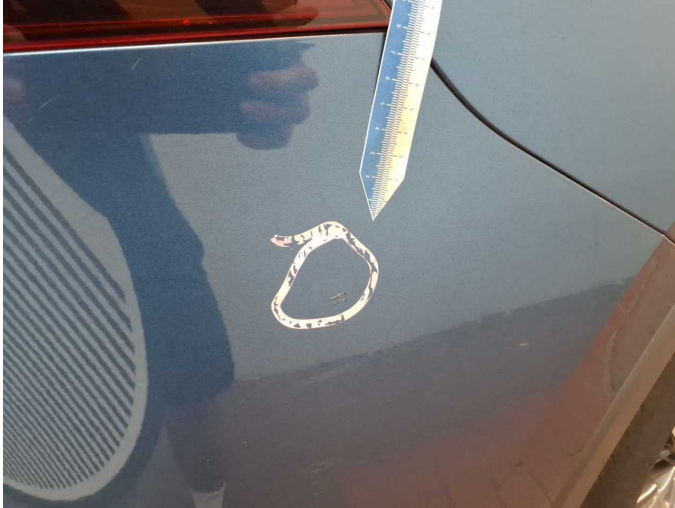
Damage 16: Rear bumper: Rear bumper - Scratch(es) - Paint

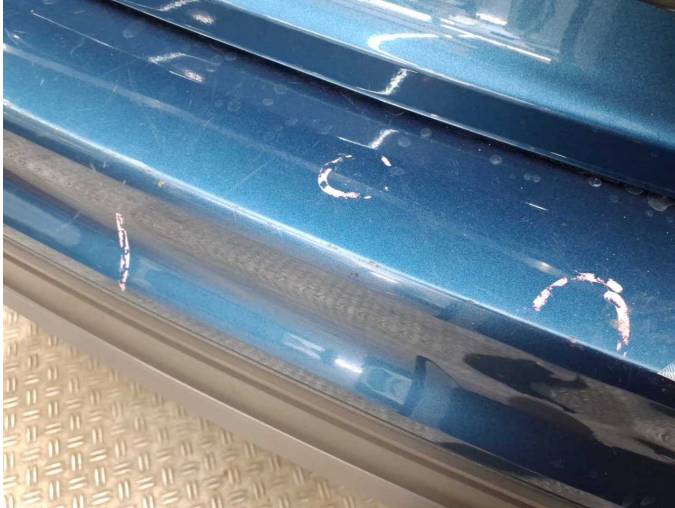
Damage 16: Rear bumper: Rear bumper - Scratch(es) - Paint

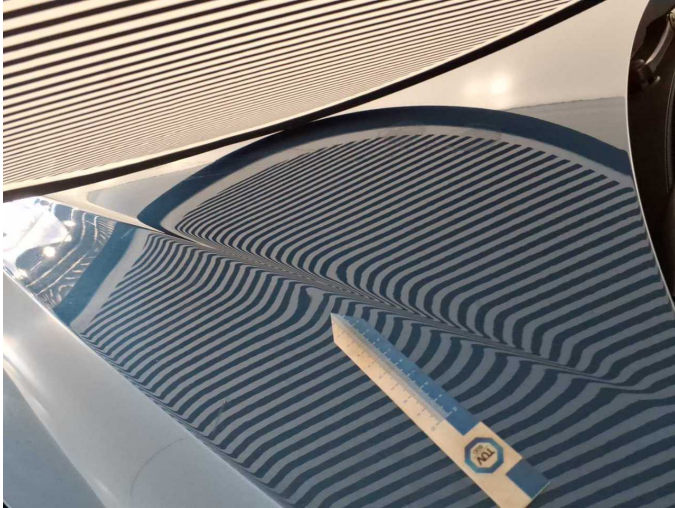
Damage 17: Bonnet: Bonnet (Verätzungen / mit Delle) - Paint defect - Repair and paint

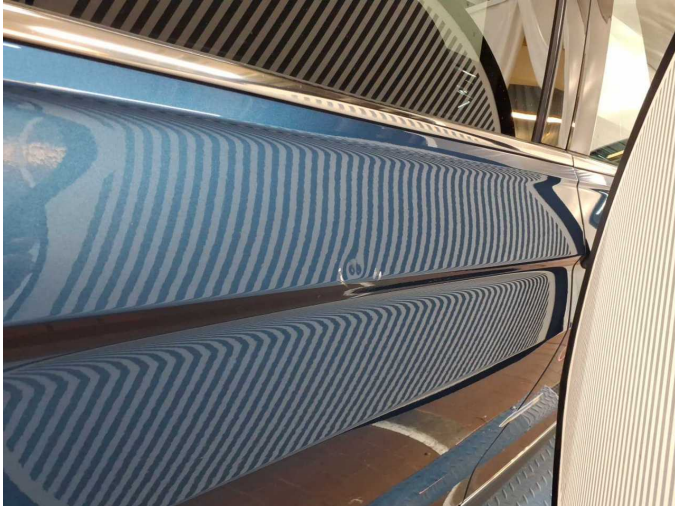
Damage 18: Door - rear right side: Door - dent(s) - Repair and paint

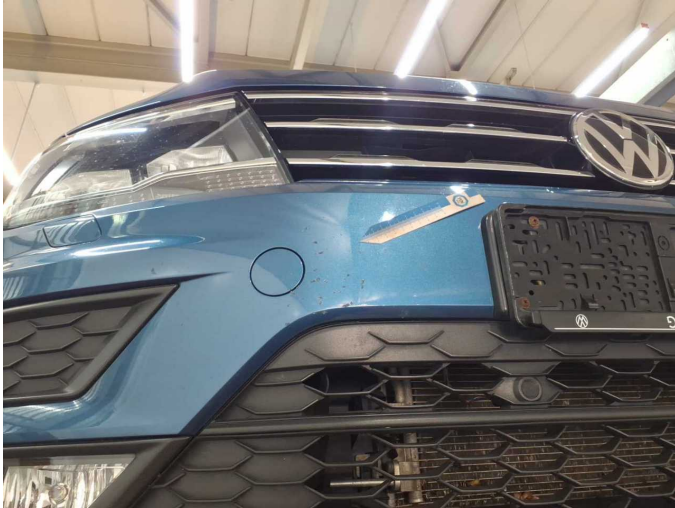
Damage 19: Front bumper: Front bumper - Scratch(es) - Paint

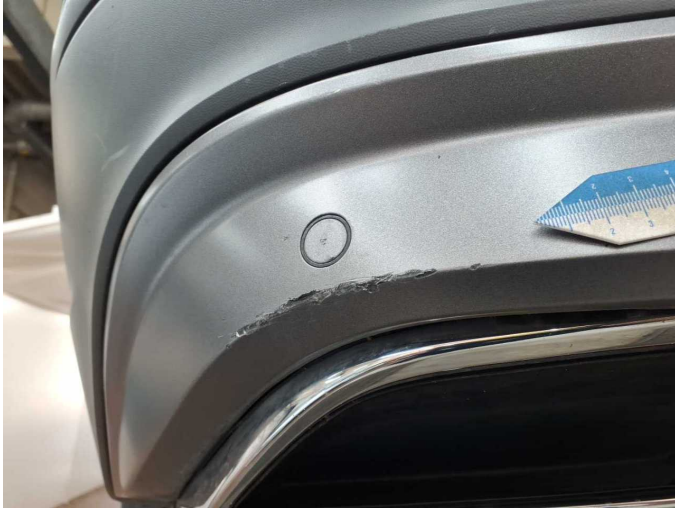
Damage 20: Rear bumper: Spoiler (Mit Blende lose) - Scratched - Paint

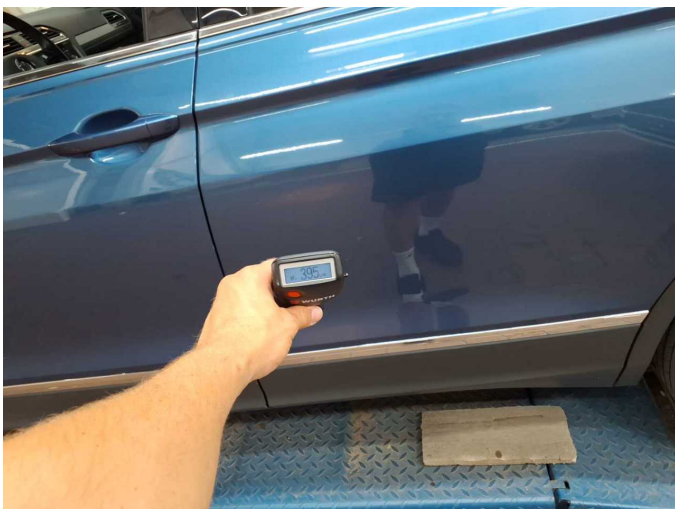
Wear and tear 8: Side panel - rear left side: Side panel - dent(s) - Repair and paint

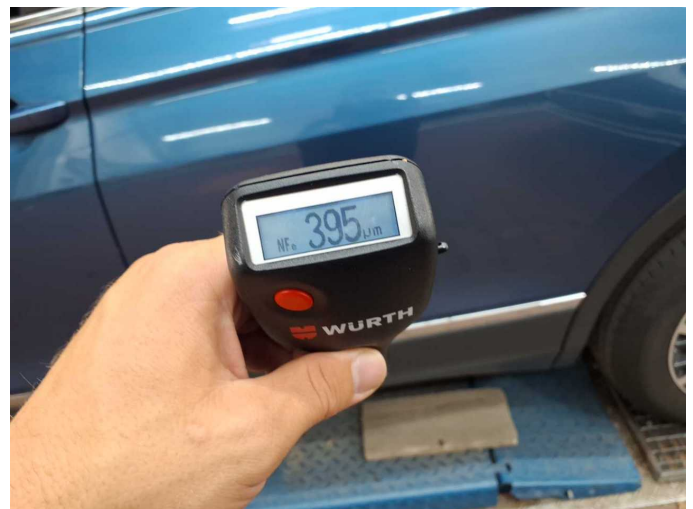
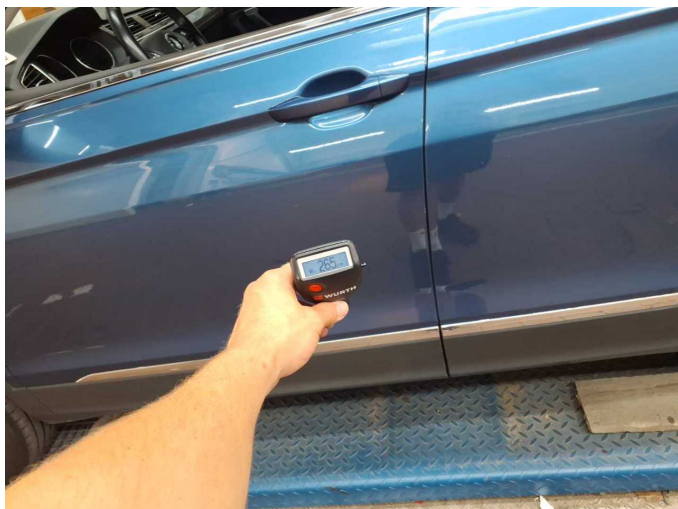
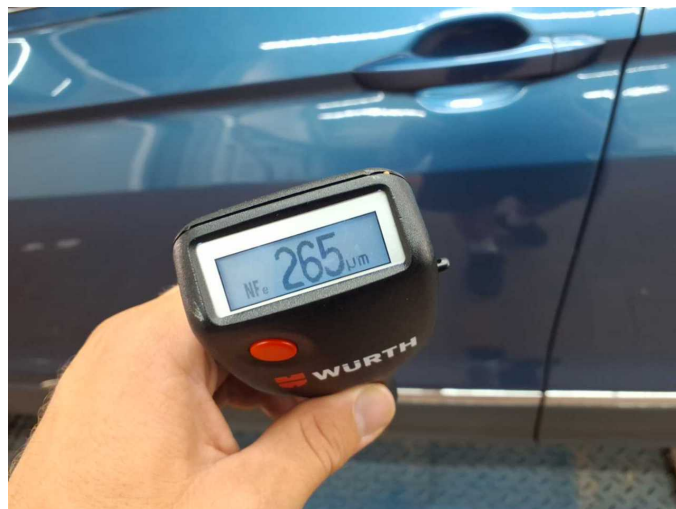
Repainting 1: Door - rear left side, Door - front left side
