Expertise

Protocol number: 46416444  
Order No. / Reference: 26678563  
Inspection date: 9 Jul 2026

Manufacturer: Ford

Model: Transit 350 L4H3 Lkw HA Trend

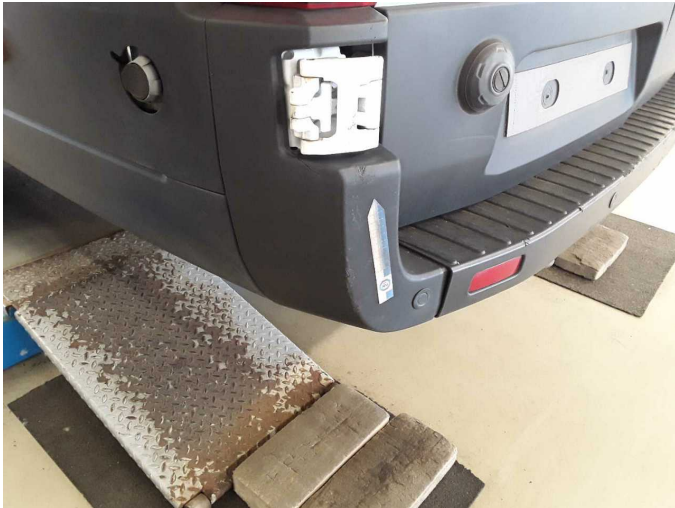
**Accident 1: Rear, Side - left**

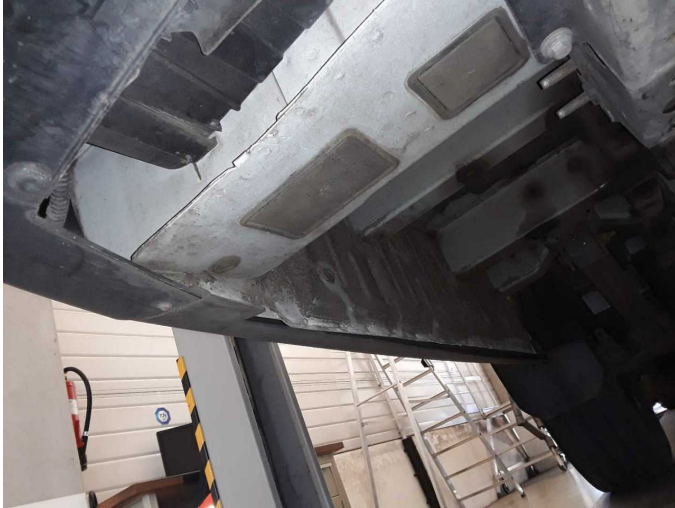
**Accident 1: Rear, Side - left**
