## Expertise

Protocol number: 46291807  
Order No. / Reference: 26153034  
Inspection date: 7 Apr 2026

Model: Vito 116 CDI Tourer Extralang Aut. PRO

VIN: W1VVLGFZ2T4546641

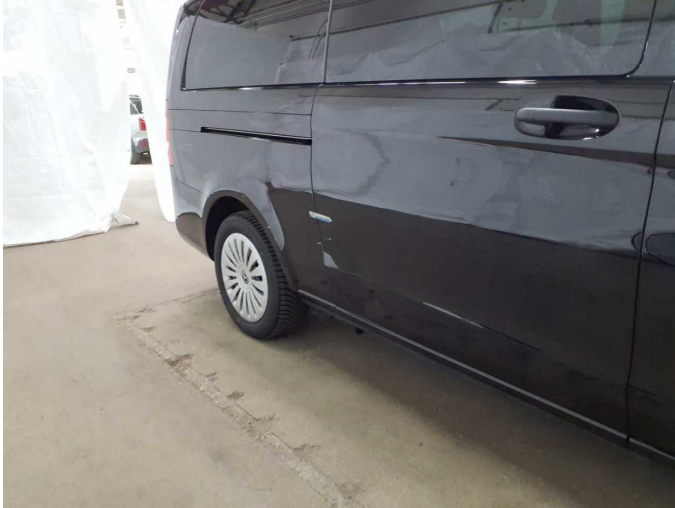
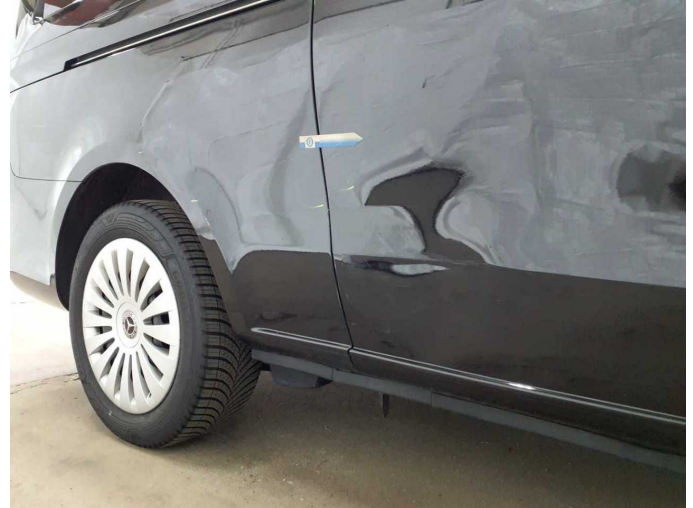
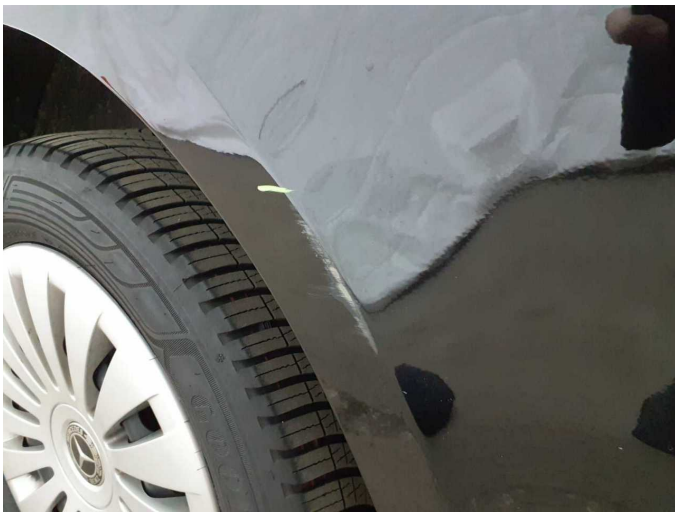
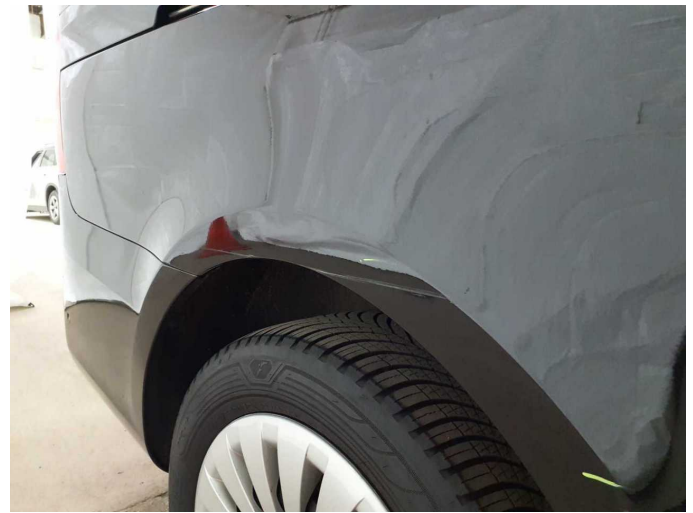
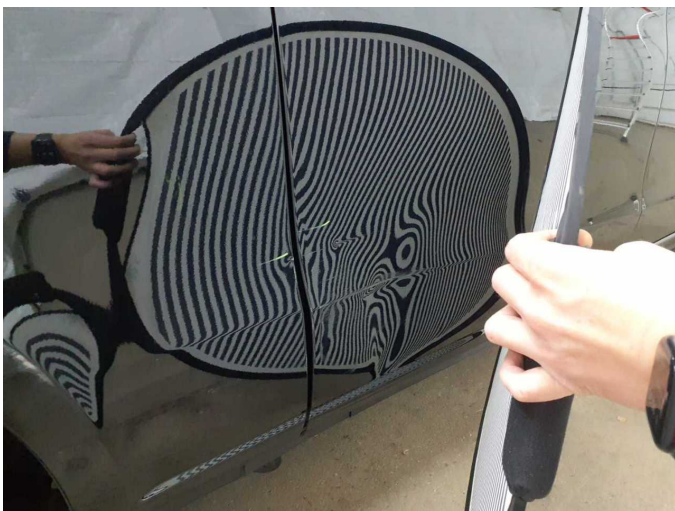
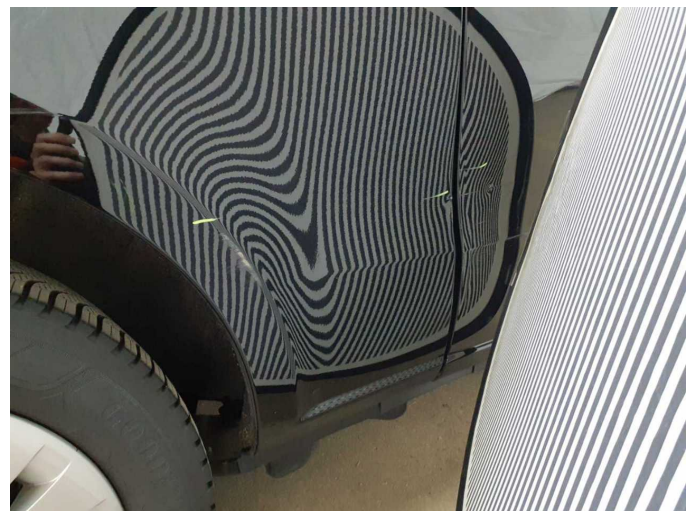
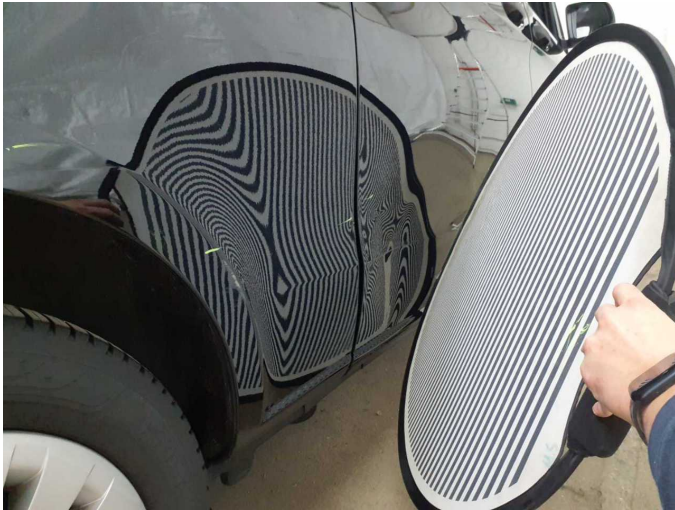
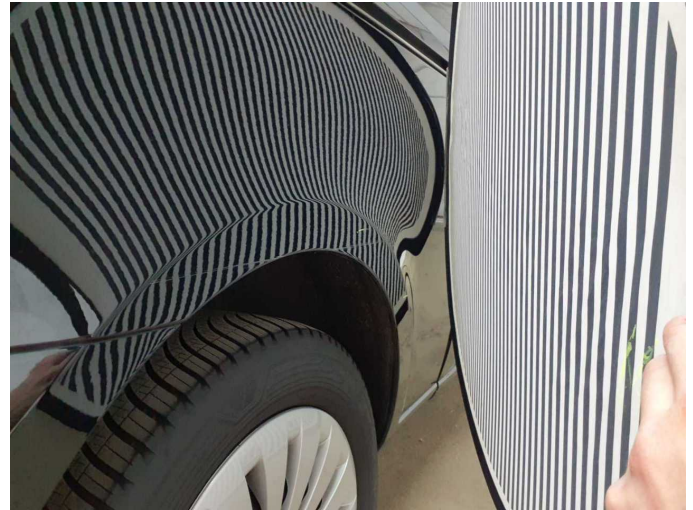
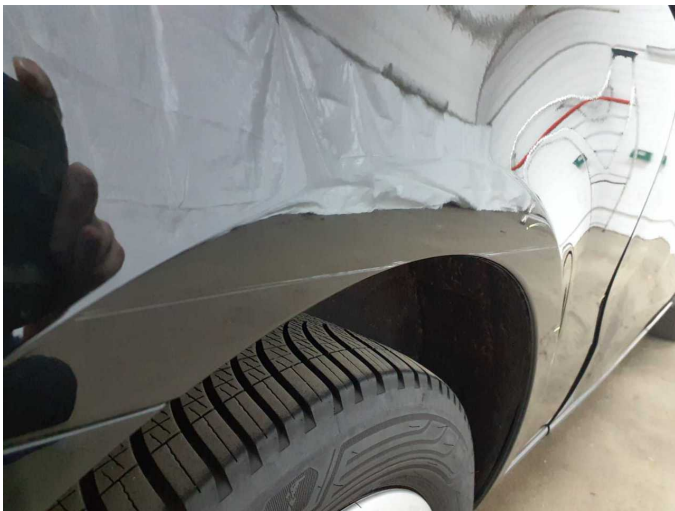
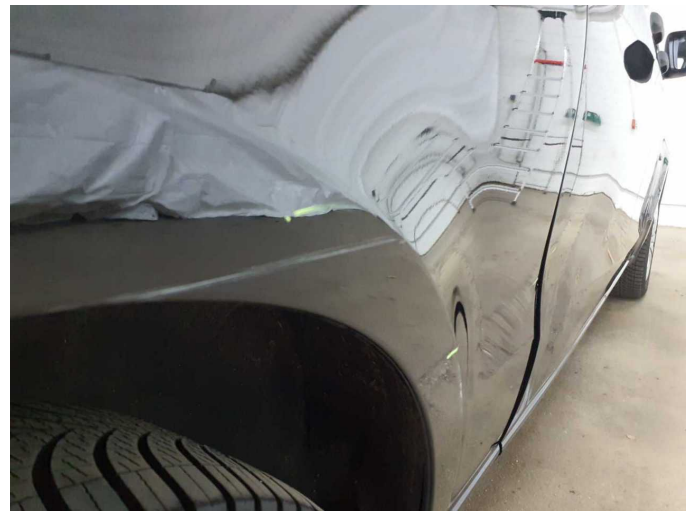
Accident 1: Side right

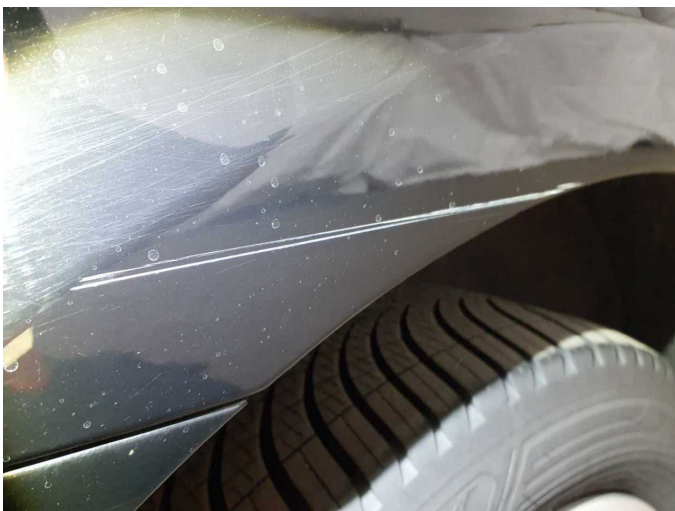
Accident 1: Side right

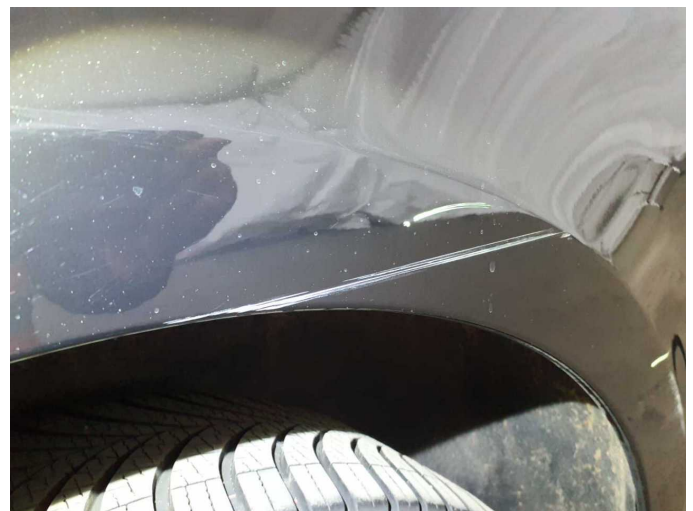
Accident 1: Side right

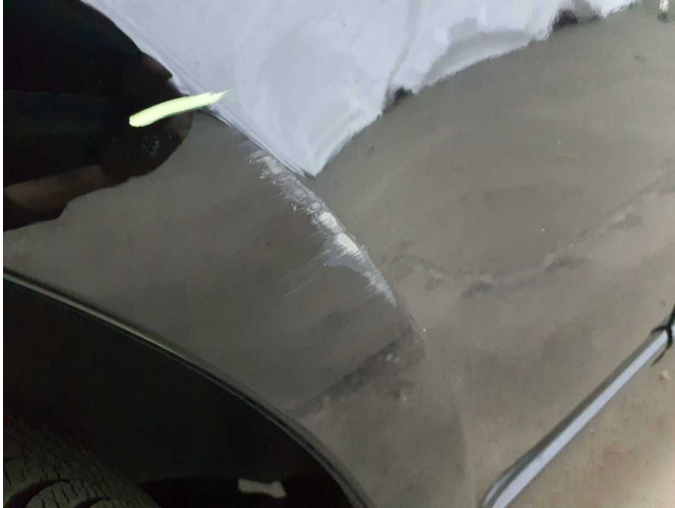
**Accident 1: Side right**

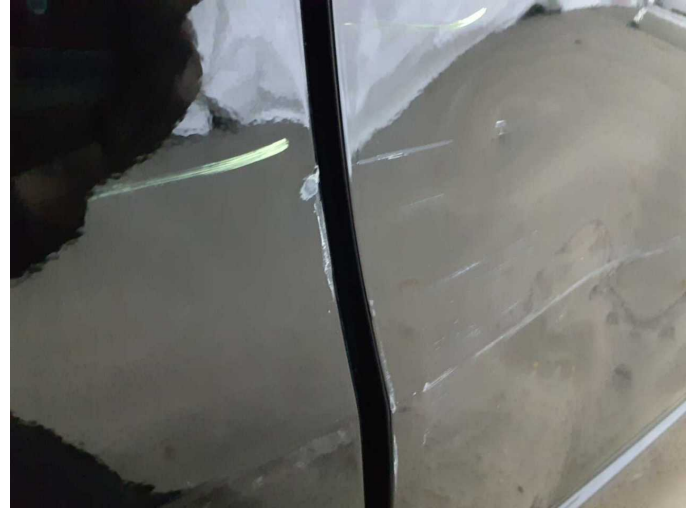
**Accident 1: Side right**

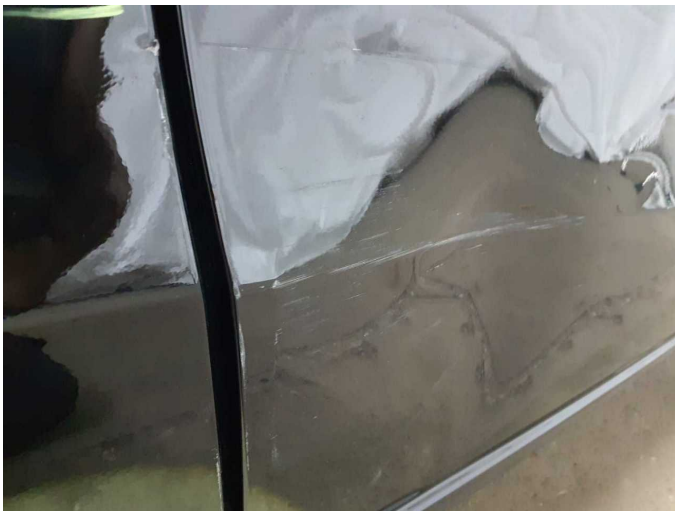
**Accident 1: Side right**

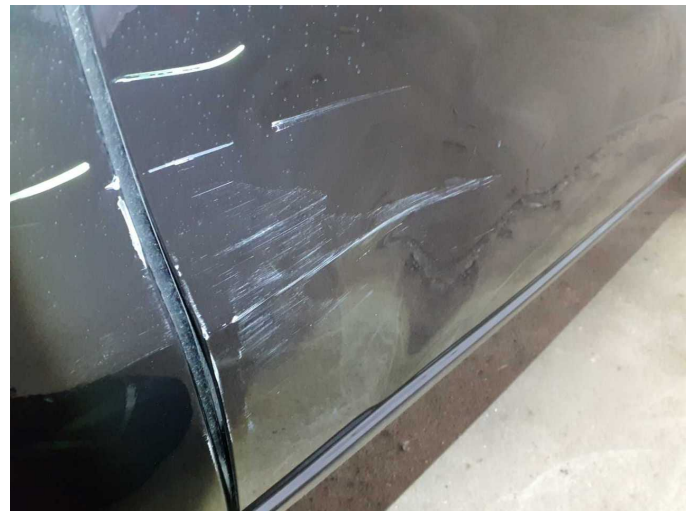
**Accident 1: Side right**
