Expertise

Protocol number: 45296696
Order No. / Reference: 26191102-1
Inspection date: 30 Mar 2026

Model: 308 SW BlueHDi 130 EAT8 Allure Pack

VIN: VR3FCYHZTNY580628

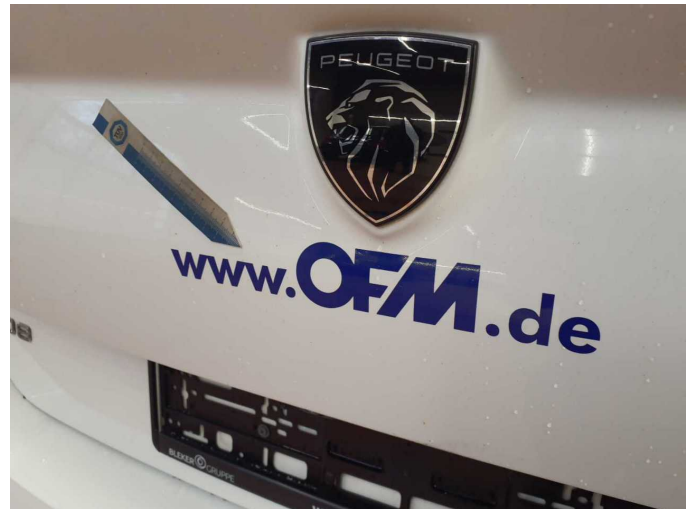
Damage 2: Boot lid / rear door: Boot lid - Glued / labelled - De-glue / neutralise

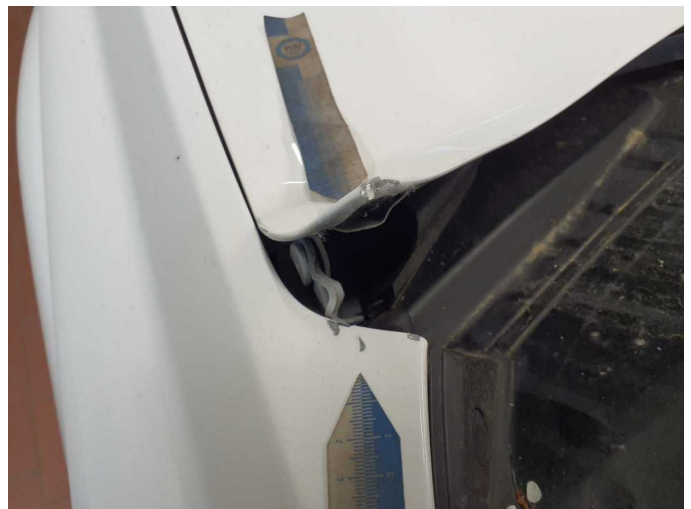
Accident 1: Front, Side - left, Side right

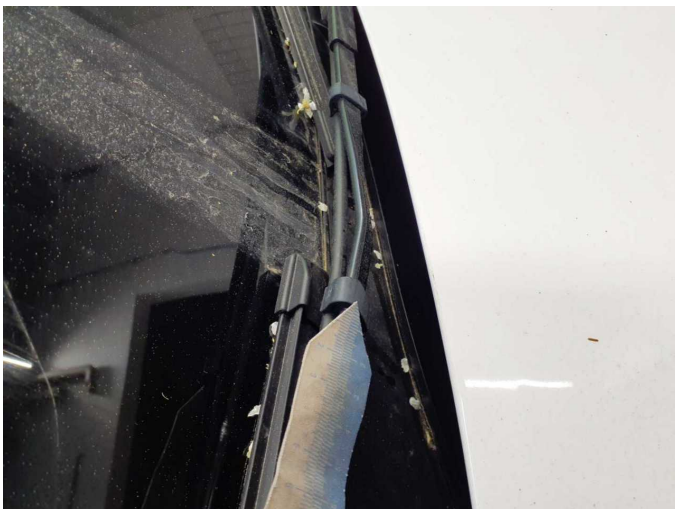
Accident 1: Front, Side - left, Side right
