Expertise

Protocol number: 46311059
Order No. / Reference: 26543486
Inspection date: 2 Jul 2026

Model: Mondeo Turnier 2.0 EcoBlue Aut. VIGNALE

VIN: WF0FXXWPCFNS68620

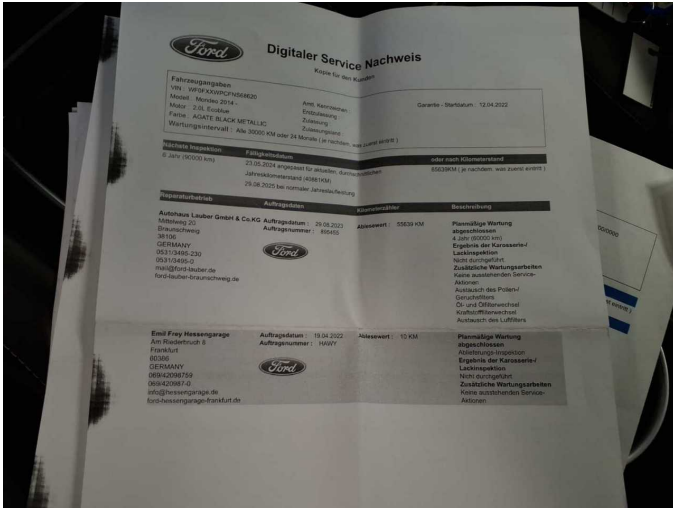
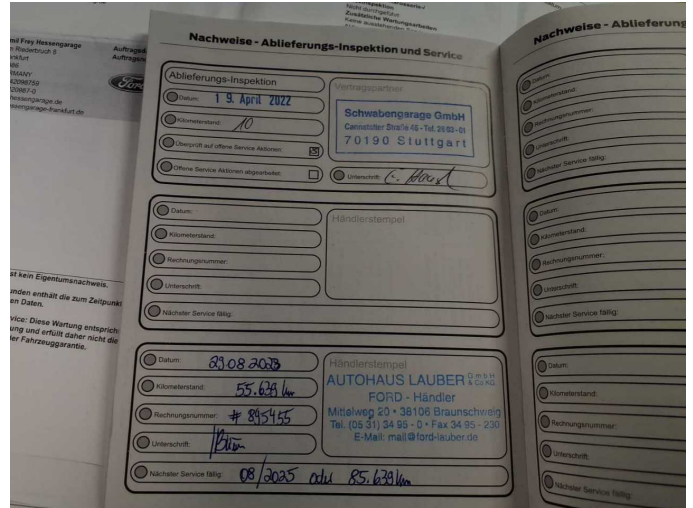
Damage 2: Misc.: Inspection / maintenance - No evidence - No deduction
