Expertise

Protocol number: 46466705  
Order No. / Reference: 26600651  
Inspection date: 10 Jul 2026

Manufacturer: Volvo

Model: XC60 T6 AWD Recharge Essential

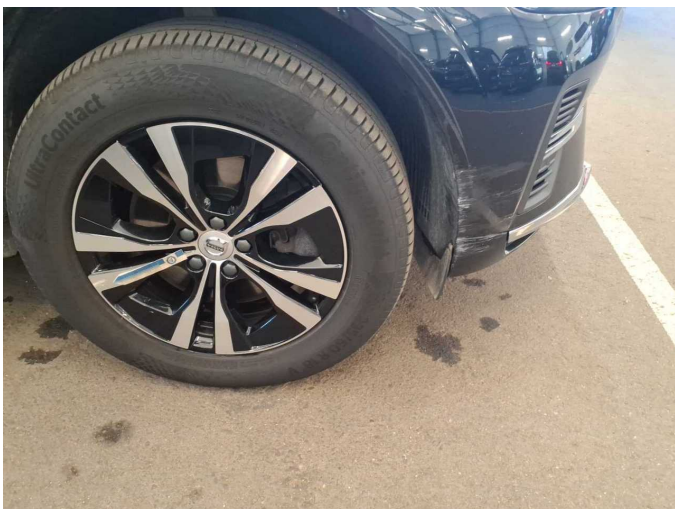
**Accident 1: Front**

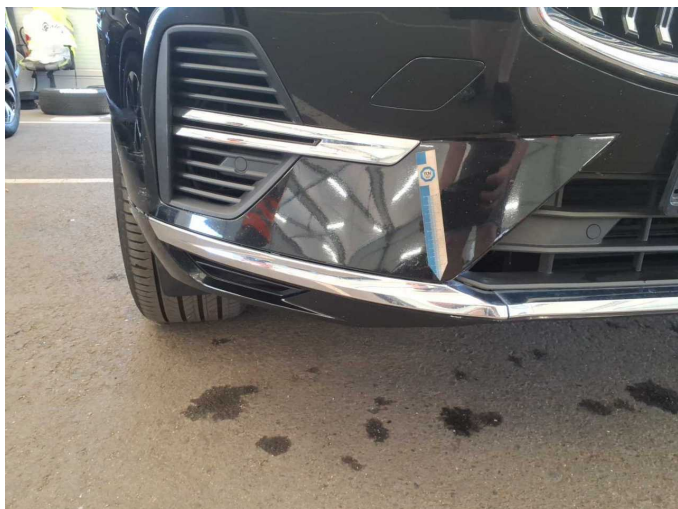
**Accident 1: Front**

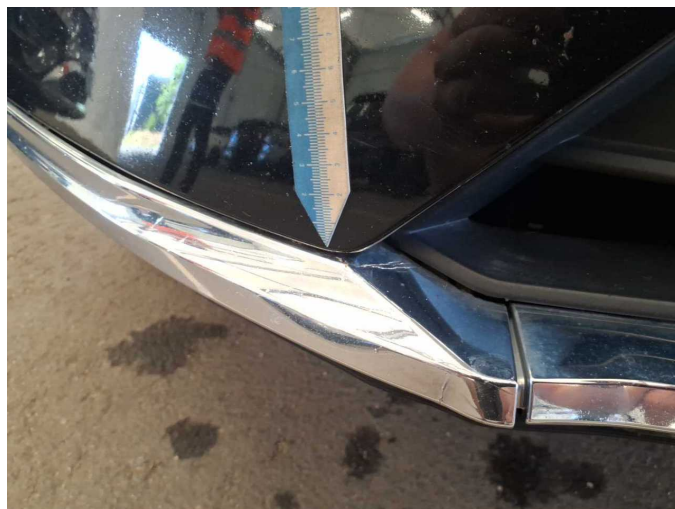
**Accident 1: Front**

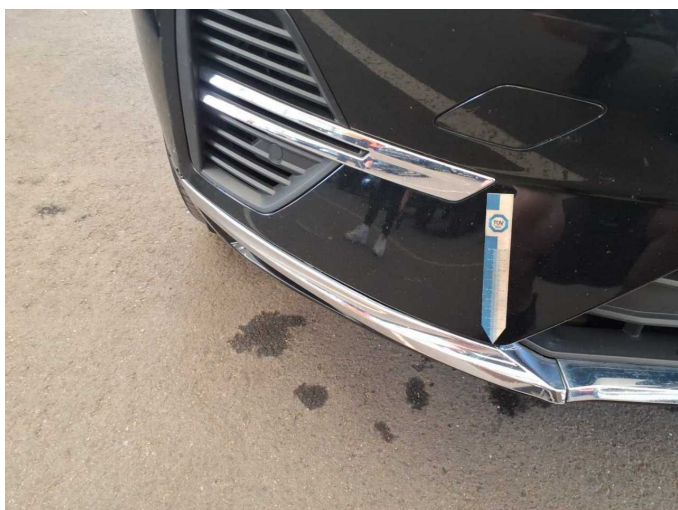
**Accident 1: Front**

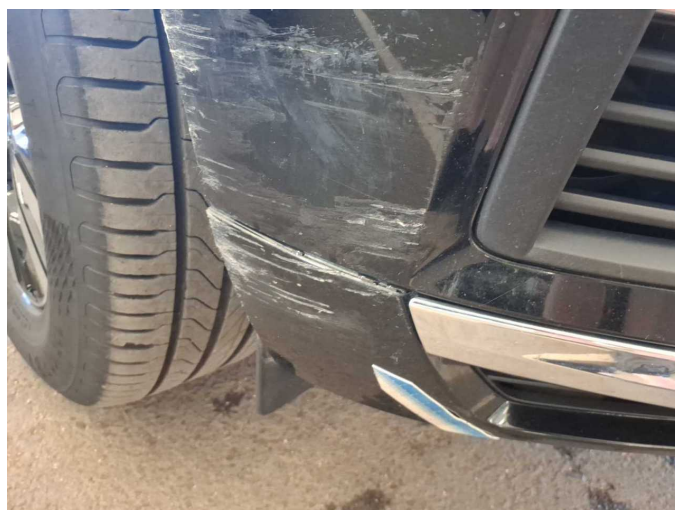
**Accident 1: Front**

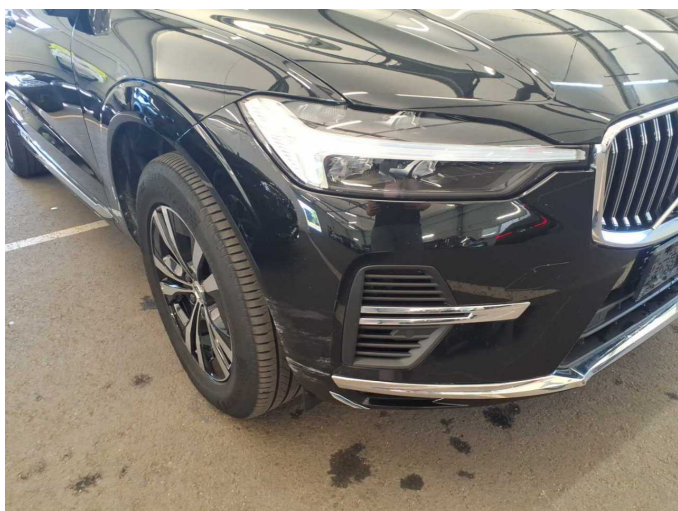
**Accident 1: Front**
