Expertise

Protocol number: 46902477  
Order No. / Reference: 26734139  
Inspection date: 5 Aug 2026

Manufacturer: Volkswagen

Model: Passat Variant 2.0 TDI SCR DSG Business

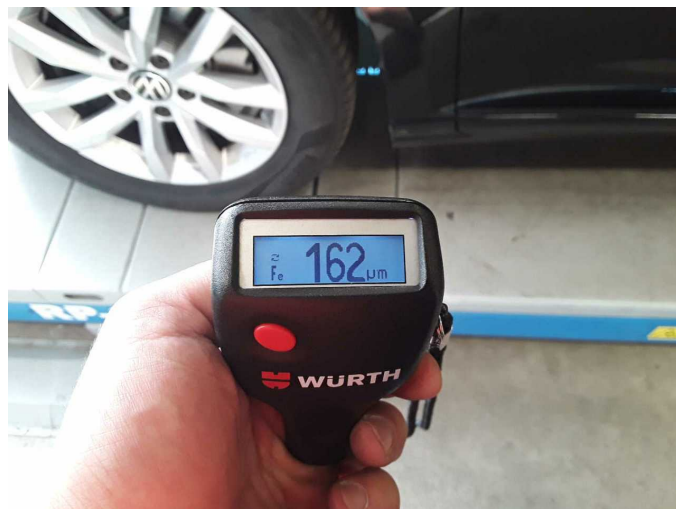
**Repainting 1:** Mudguard - left side
