Expertise

Protocol number: 46653862  
Order No. / Reference: 26621839  
Inspection date: 22 Jul 2026

Model: Zafira Life 2.0 D M Aut. Edition

VIN: VXEEVHZ7NZ024899

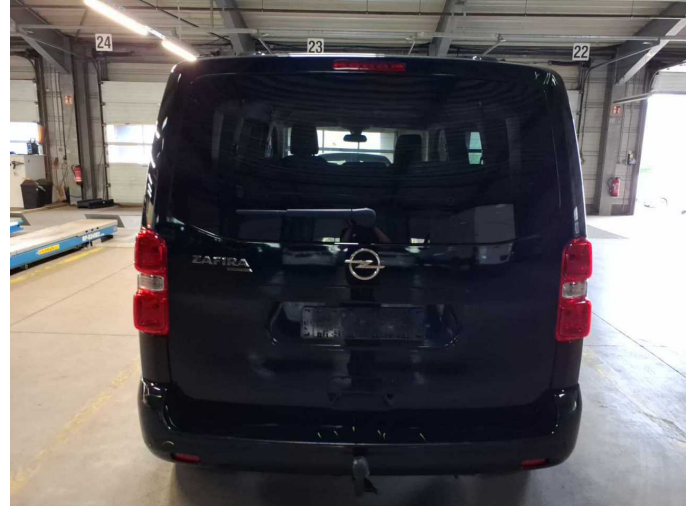
**Repainting 1:** Boot lid / rear door

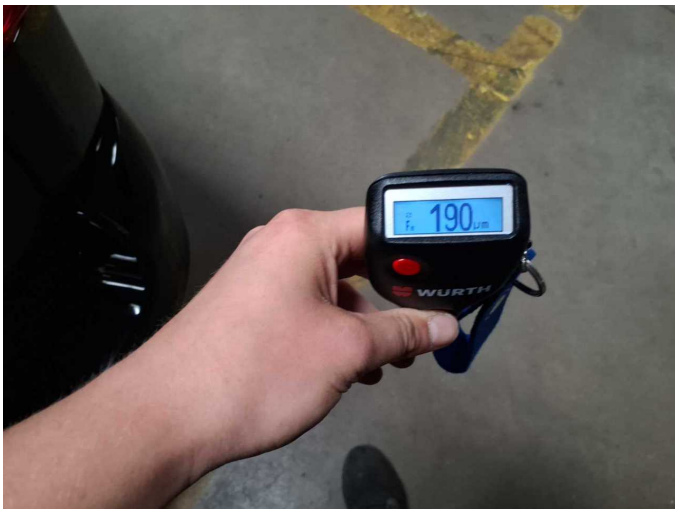
**Boot lid / rear door:** 190 µm
