Expertise

Protocol number: 46709457  
Order No. / Reference: 26725739  
Inspection date: 24 Jul 2026

Manufacturer: Ford

Model: Tourneo Connect 2.0 EcoBlue TITANIUM

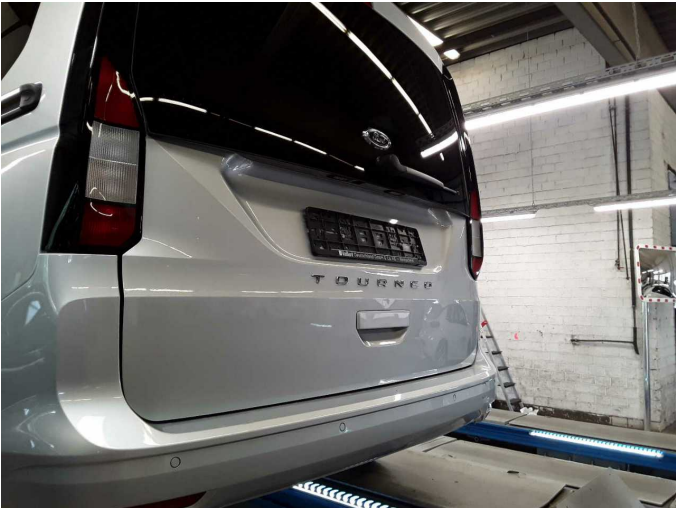
**Repainting 1:** Boot lid / rear door, Side panel - rear left side, Door - rear left side
