Expertise

Protocol number: 46385288  
Order No. / Reference: 26512547  
Inspection date: 2 Jul 2026

Manufacturer: Skoda  
VIN: TMBJC7NY9NF019119

Model: Enyaq iV 80

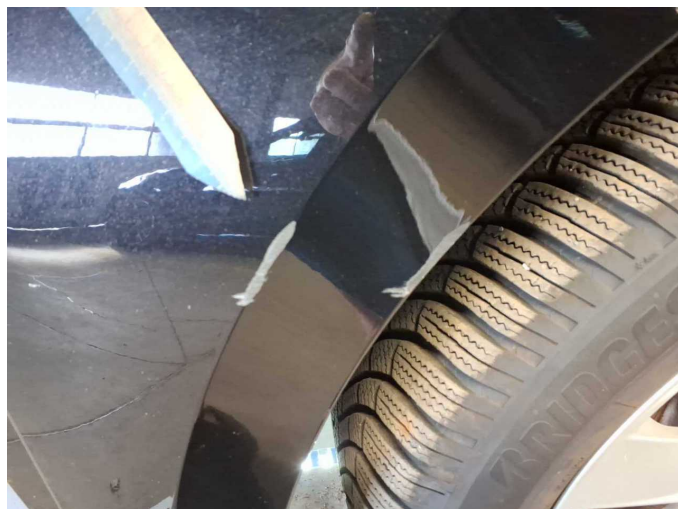
**Accident 1: Front, Side - left**

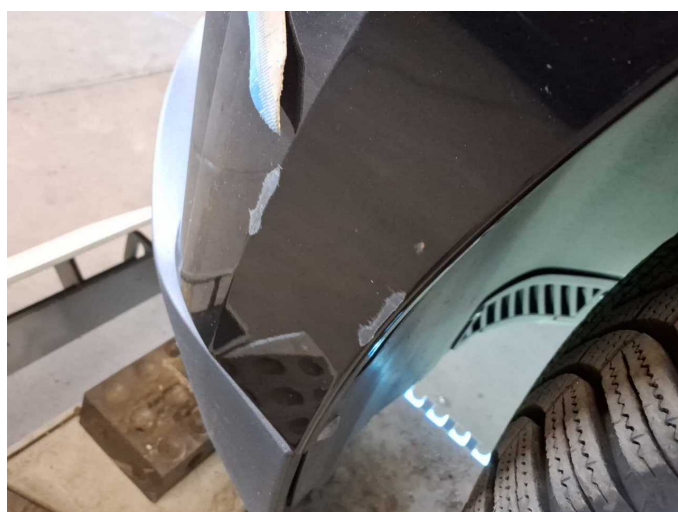
**Accident 1: Front, Side - left**

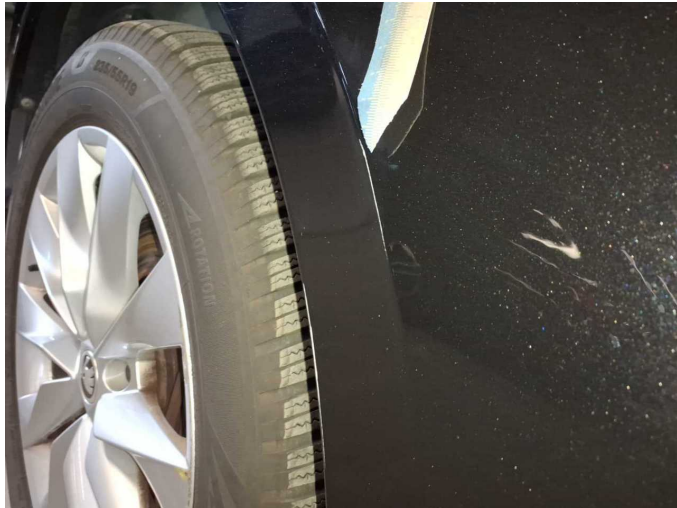
**Accident 1:** Front, Side - left

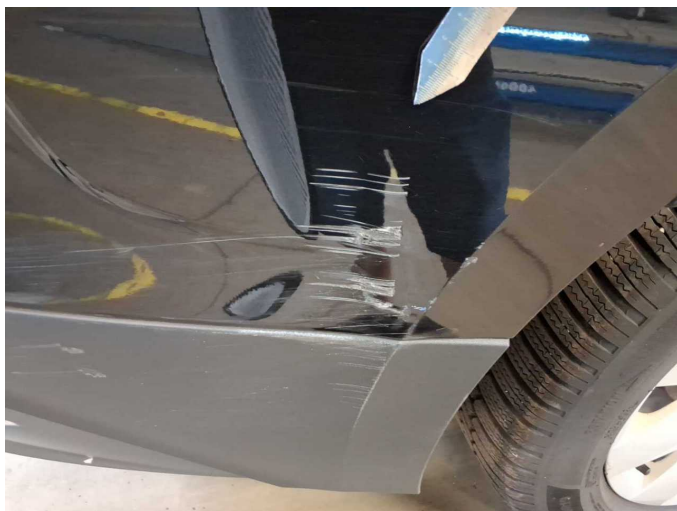
**Accident 2:** Rear, Side right

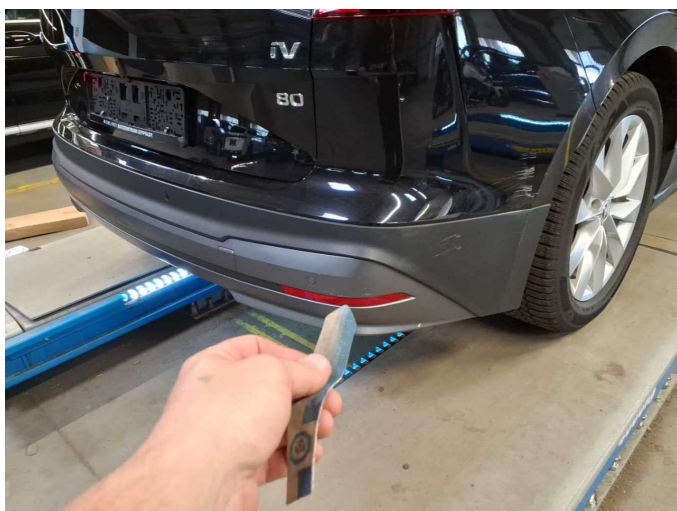
**Accident 2:** Rear, Side right

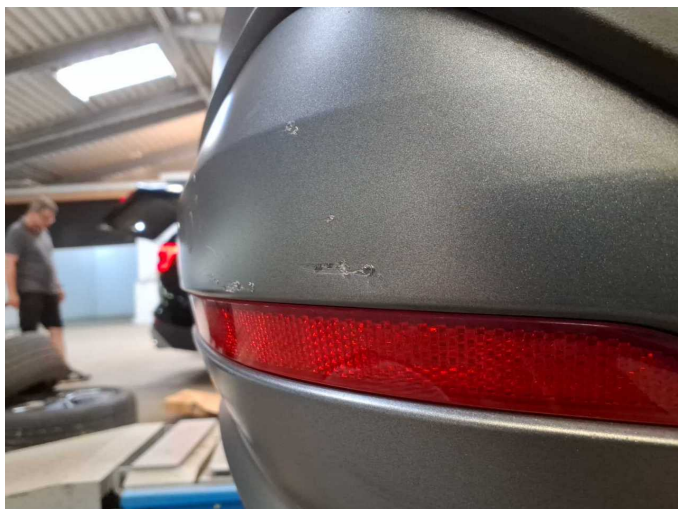
**Accident 2: Rear, Side right**

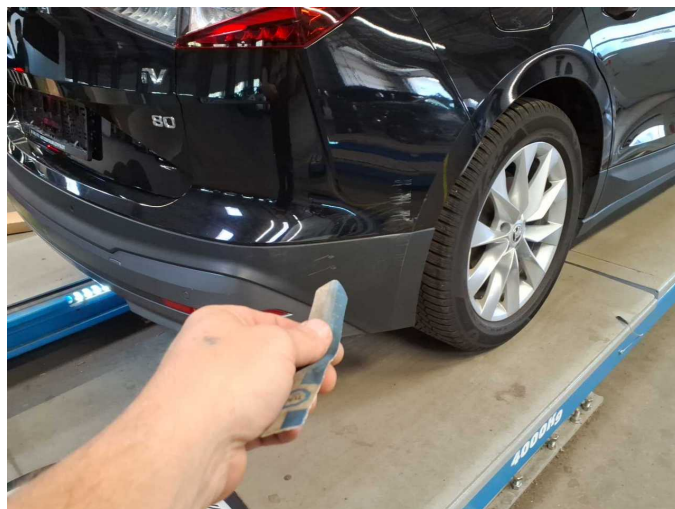
**Accident 2: Rear, Side right**

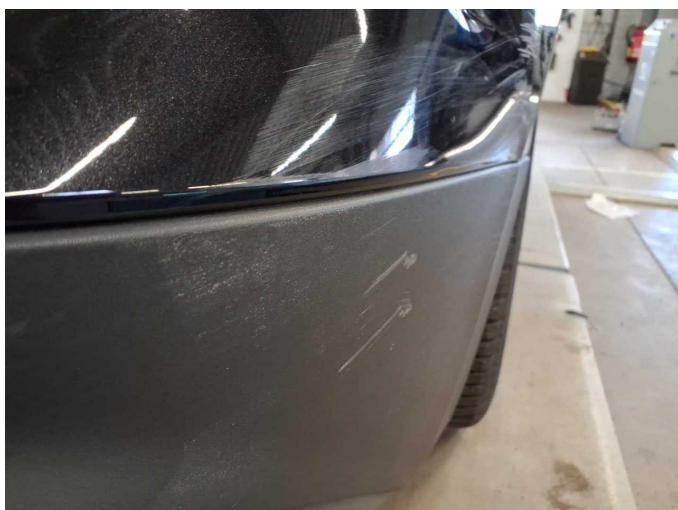
**Accident 2: Rear, Side right**

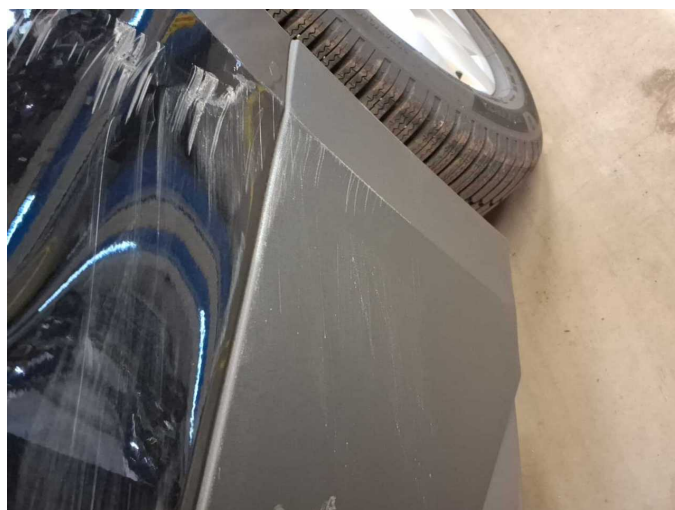
**Accident 2: Rear, Side right**

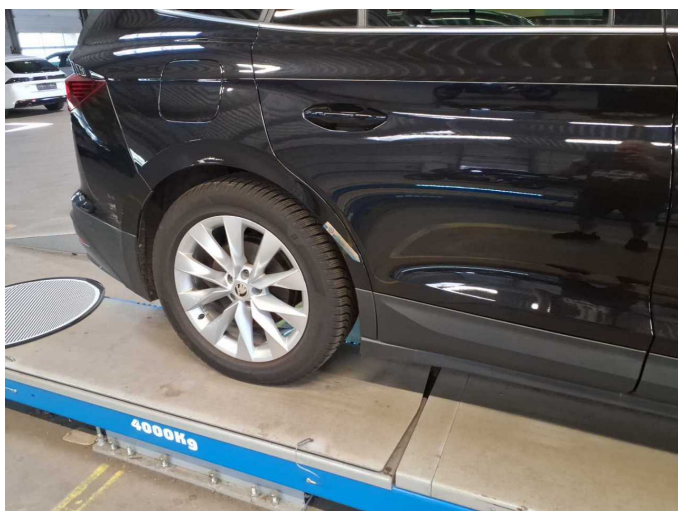
**Accident 2: Rear, Side right**

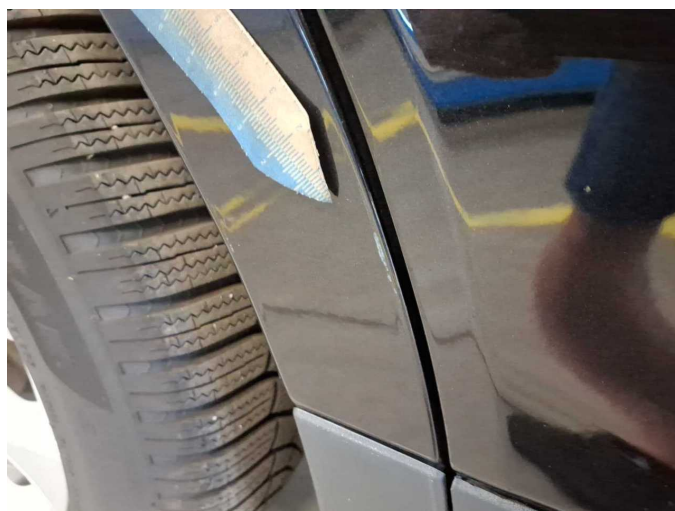
**Accident 2: Rear, Side right**

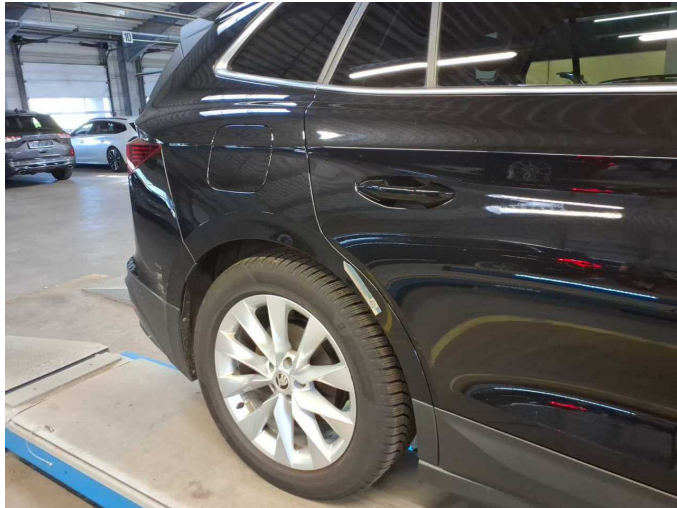
**Accident 2:** Rear, Side right

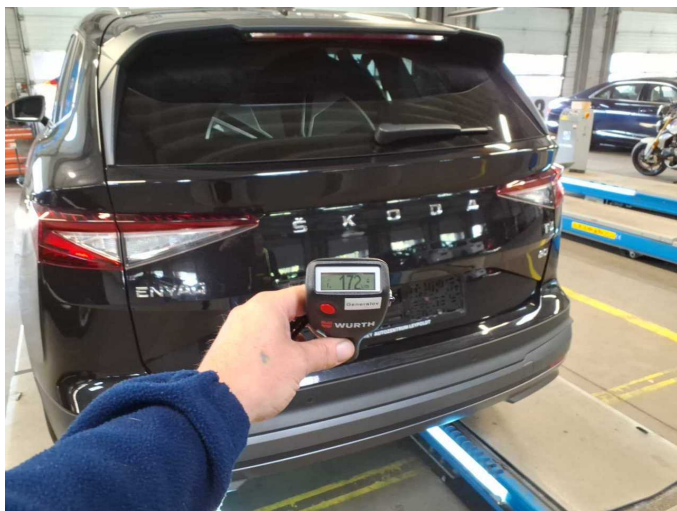
**Repainting 1:** Boot lid / rear door

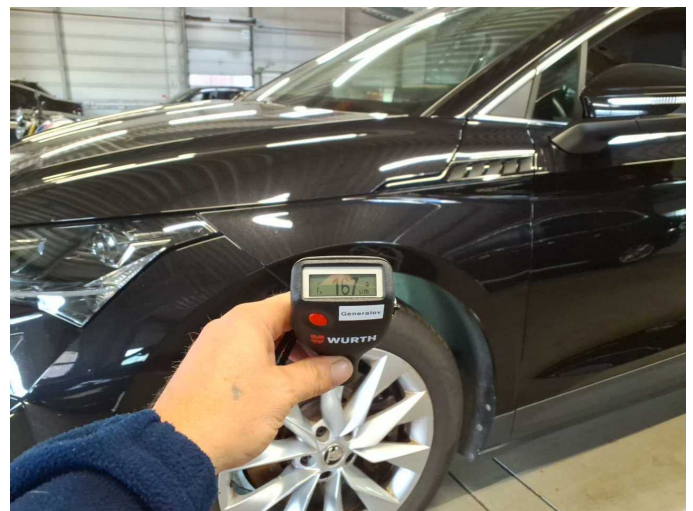
**Repainting 2:** Mudguard - left side

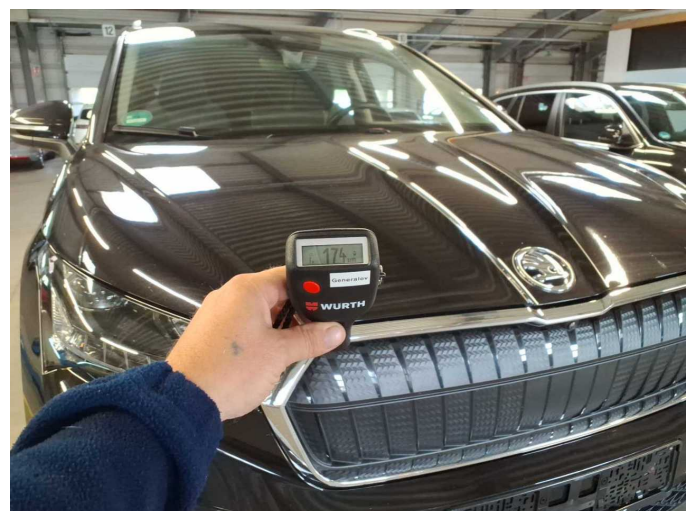
**Repainting 4:** Bonnet

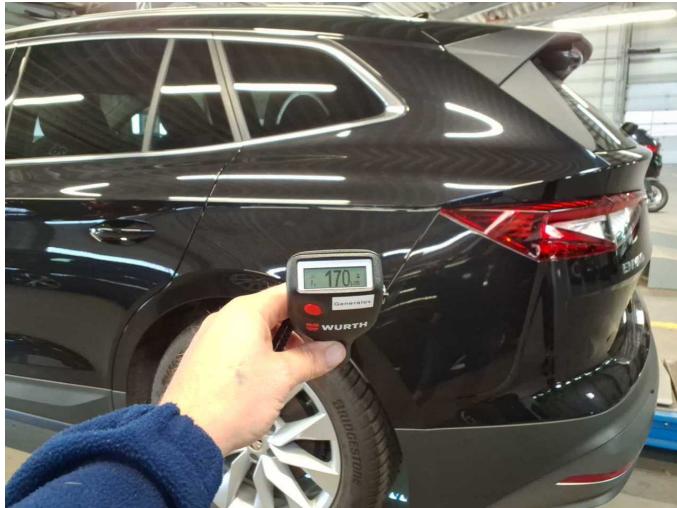
**Repainting 5:** Side panel - rear left side

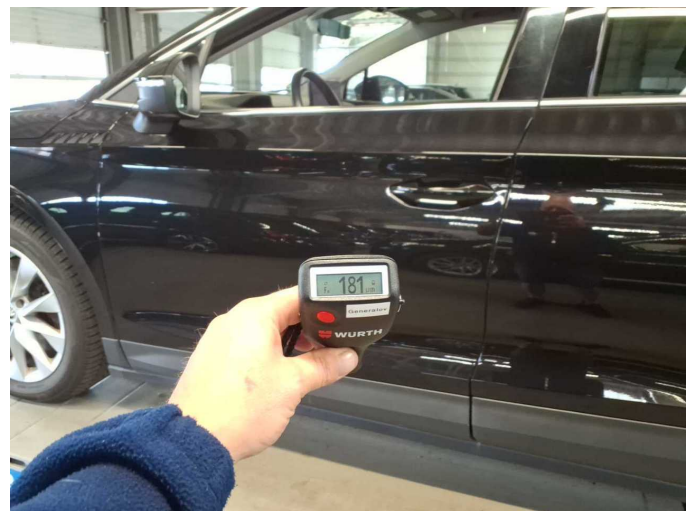
**Repainting 8:** Door - front left side
