Expertise

Protocol number: 45470703
Order No. / Reference: 26296220
Inspection date: 6 May 2026

Model: Tiguan 2.0 TDI SCR DSG Elegance

VIN: WVGZZZ5NZMW062891

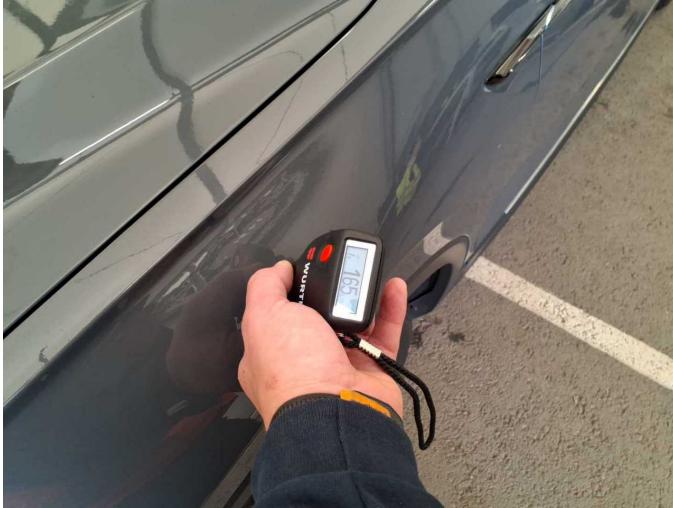
Repainting 1: Door - rear left side, Door - front left side
