Expertise

Protocol number: 46209499
Order No. / Reference: 26543743
Inspection date: 26 Jun 2026

Manufacturer: Peugeot

Model: 308 SW BlueHDi 130 Allure

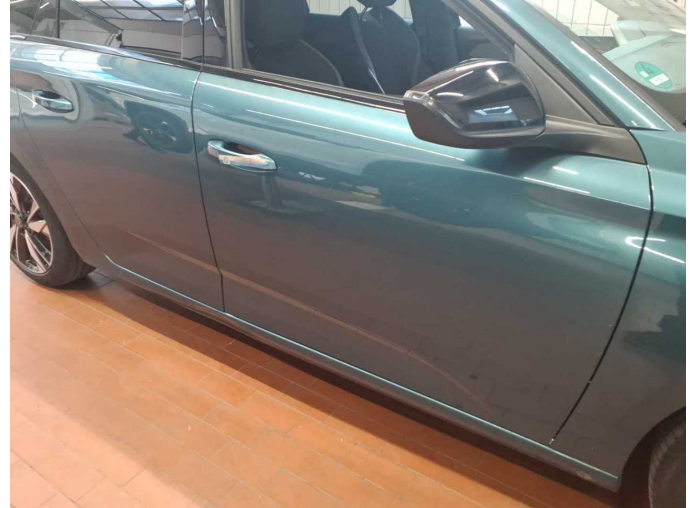
Damage 1: Door - front right side: Door handle - outside - Scratch(es) - Smart repair
