Expertise

Protocol number: 46867776  
Order No. / Reference: 26715258  
Inspection date: 3 Aug 2026

Model: Arona 1.0 TSI OPF Style

VIN: VSSZZKJZNR043302

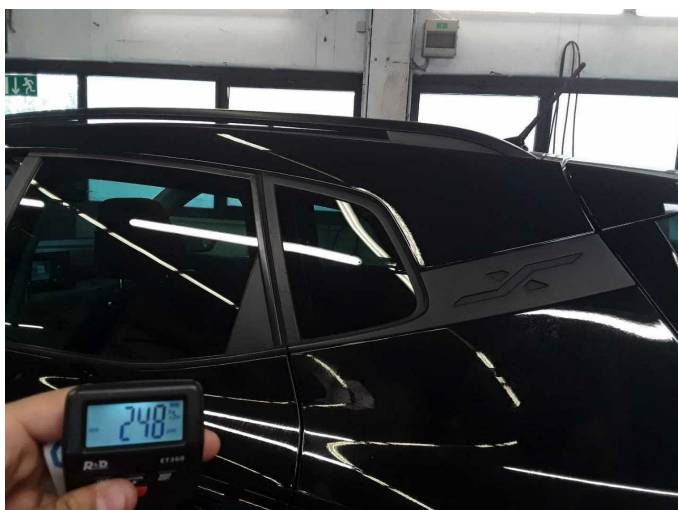
**Roof rail - left side:** 248 µm

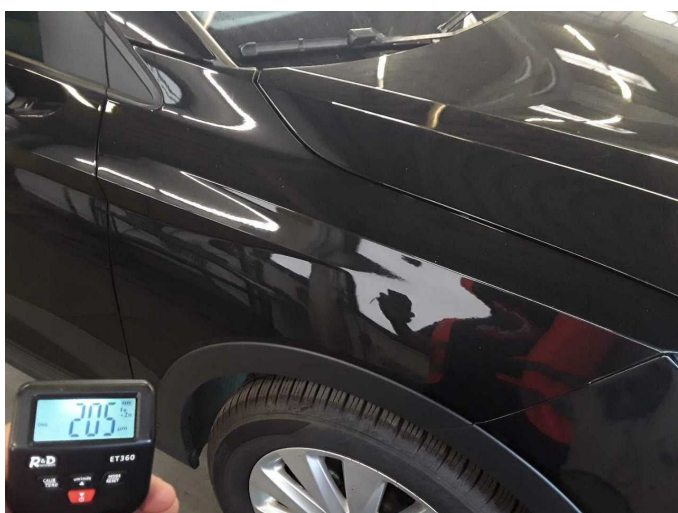
**Mudguard - right side:** 205 µm

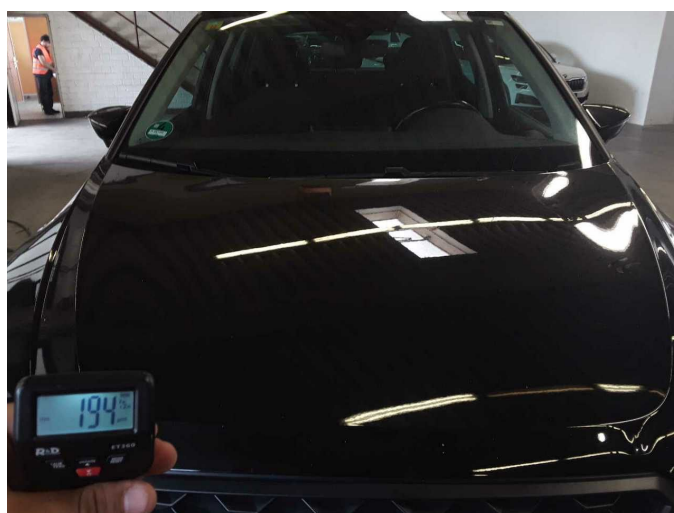
**Bonnet:** 194 µm

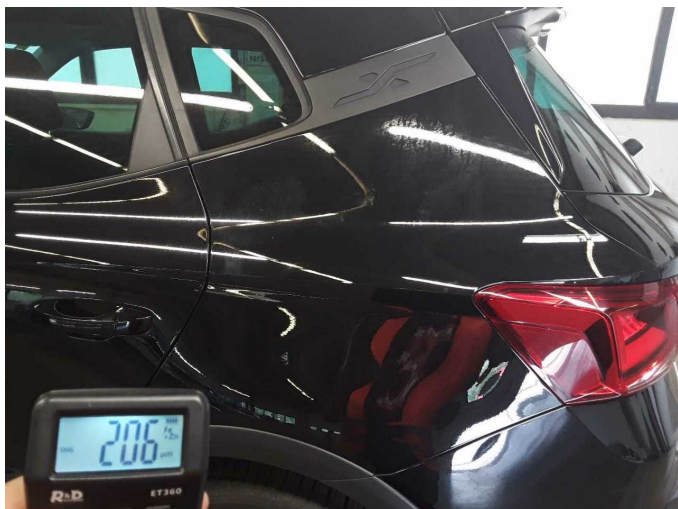
Side panel - rear left side: 206 µm

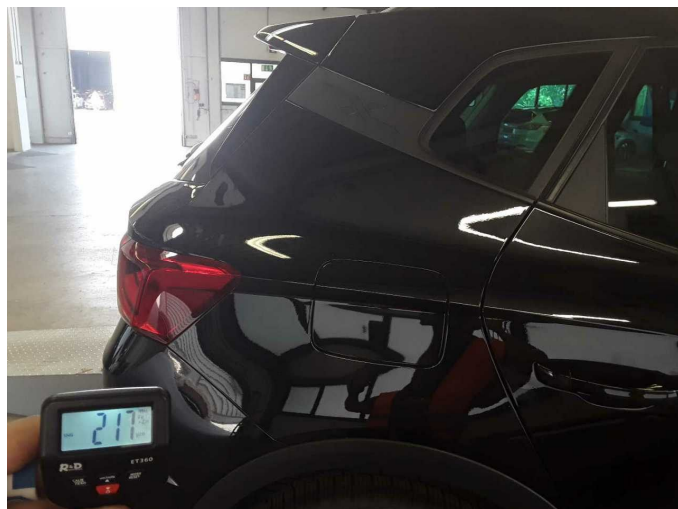
Side panel - rear right side: 217 µm

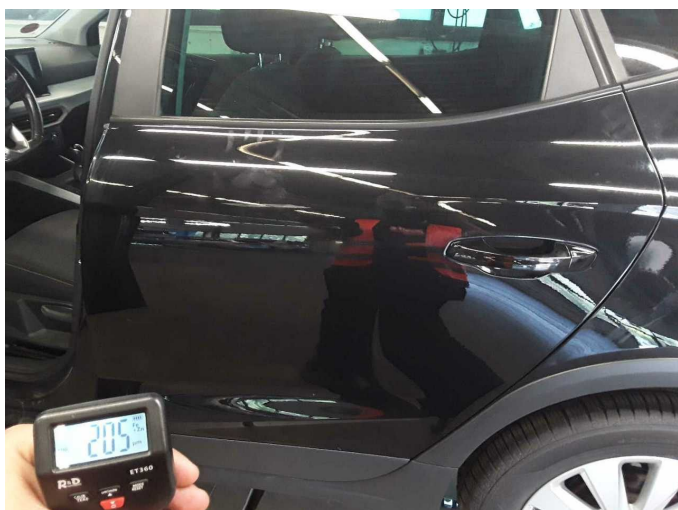
Door - rear left side: 205 µm

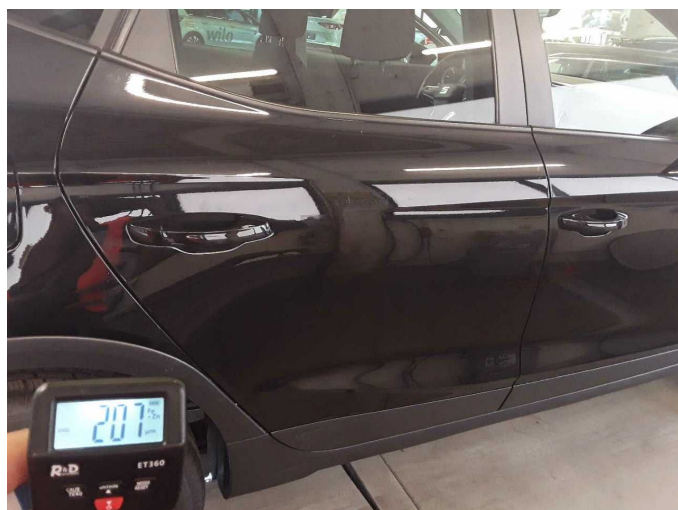
Door - rear right side: 207 µm

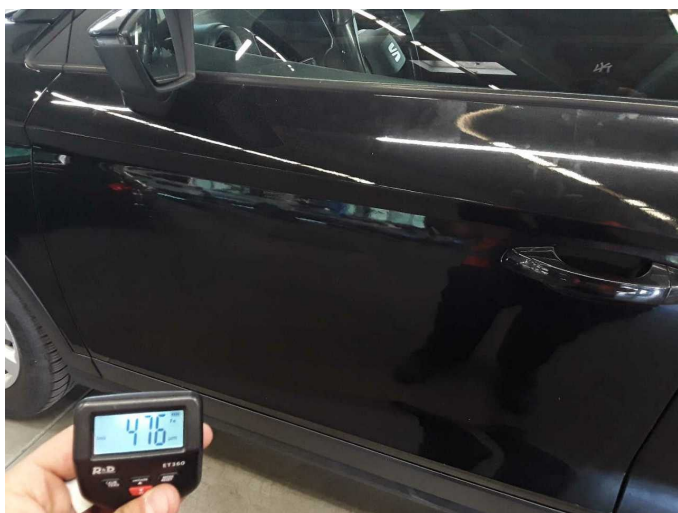
| <b>Previous damage / Accident</b> | Detectable | <b>Repainting</b> | Detectable |

Door - front left side: 476 µm

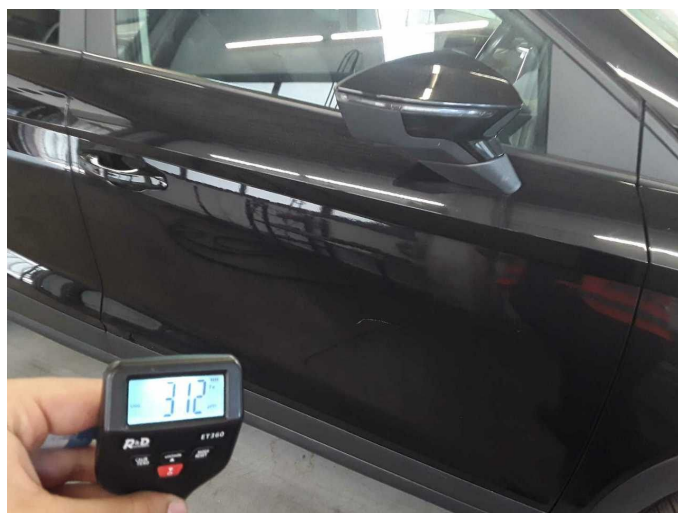
Door - front right side: 312 µm
