INSPECTION REPORT

End of contract

File	305527
License plate	1YRL815
Vehicle identification number	W0VVS3601LB215037
Dossier	2019290173
Make	Opel Mov.CDTI 150 L2H1 3.5T DC
Mileage	53255
First registration	01/01/2021
client availability date	11/02/2026
inspectionDate	05/03/2026

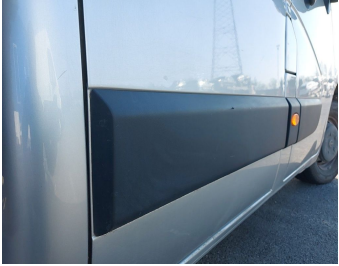
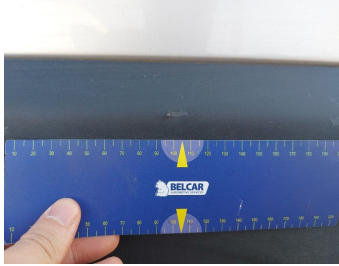
Damage within Renta-norm-hole
