Expertise

Protocol number: 46365872  
Order No. / Reference: 26641733  
Inspection date: 2 Jul 2026

Manufacturer: Ford

Model: Focus Turnier 1.5 EcoBlue Start-Stopp-System  
COOL&CONNECT

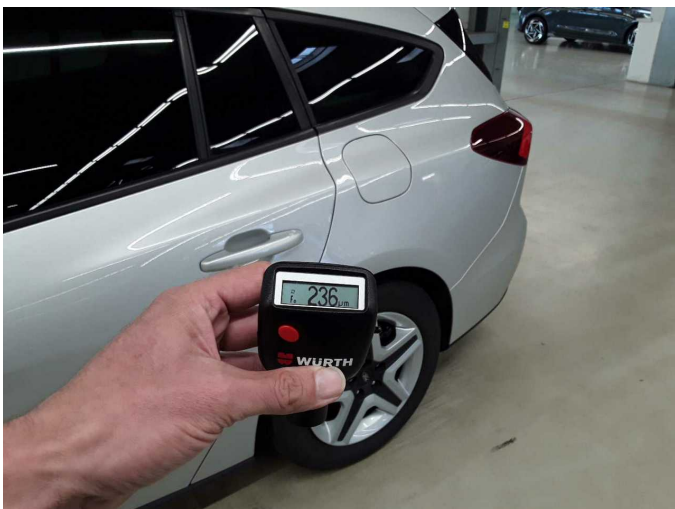
**Repainting 1:** Roof rail - left side, Mudguard - left side, Mudguard - right side, Side panel - rear left side, Side panel - rear right side, Door - rear left side, Door - rear right side, Door - front left side, Door - front right side

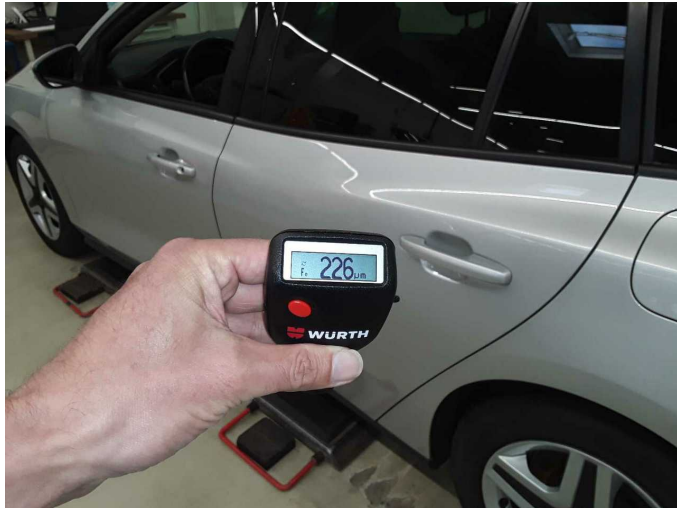
**Repainting 1:** Roof rail - left side, Mudguard - left side, Mudguard - right side, Side panel - rear left side, Side panel - rear right side, Door - rear left side, Door - rear right side, Door - front left side, Door - front right side

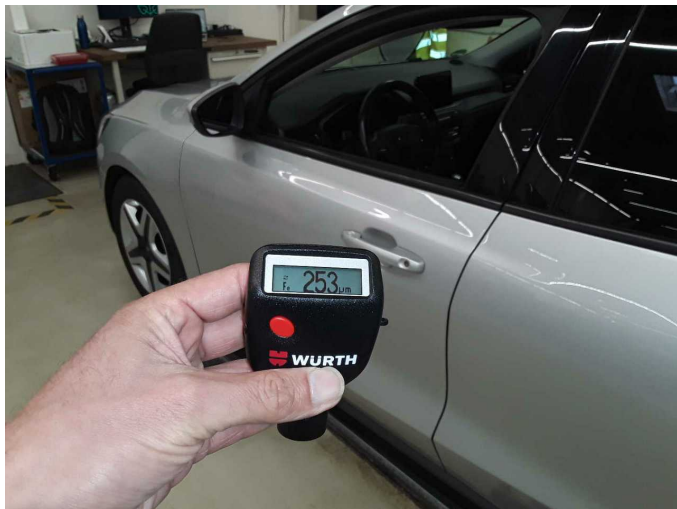
**Repainting 1:** Roof rail - left side, Mudguard - left side, Mudguard - right side, Side panel - rear left side, Side panel - rear right side, Door - rear left side, Door - rear right side, Door - front left side, Door - front right side

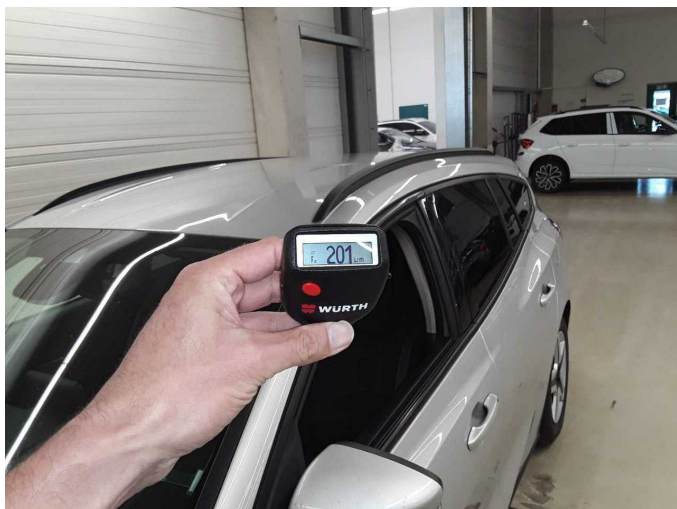
**Repainting 1:** Roof rail - left side, Mudguard - left side, Mudguard - right side, Side panel - rear left side, Side panel - rear right side, Door - rear left side, Door - rear right side, Door - front left side, Door - front right side

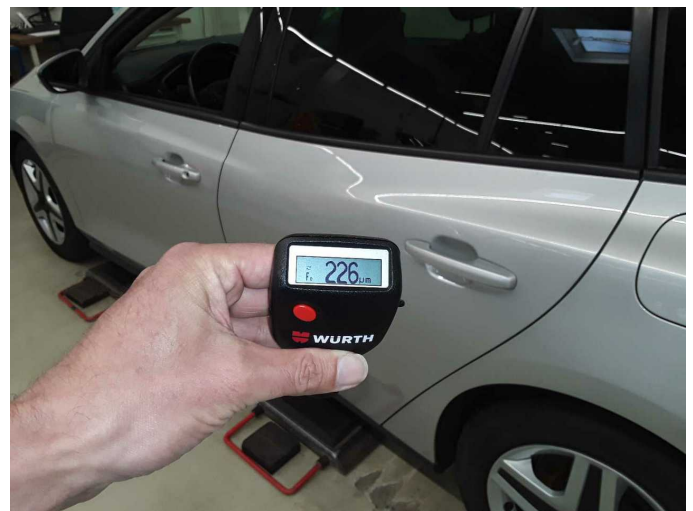
**Door - rear left side: 226 µm**

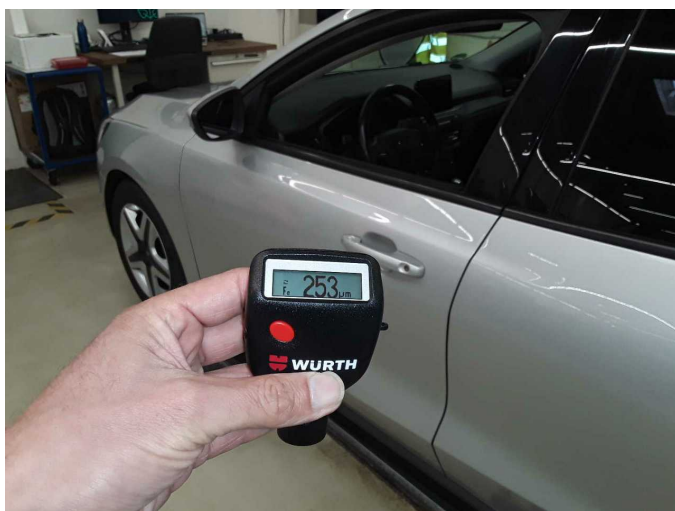
**Door - front left side: 253 µm**
