Expertise

Protocol number: 46381034  
Order No. / Reference: 26503772  
Inspection date: 7 Jul 2026

Manufacturer: Skoda  
VIN: TMBJH9NPXL7058247

Model: Superb Combi 2.0 TDI DSG L&K

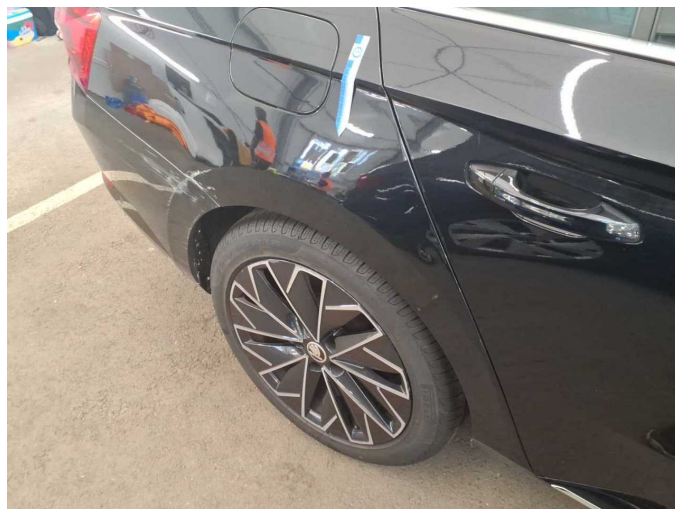
**Accident 1:** Rear, Side right

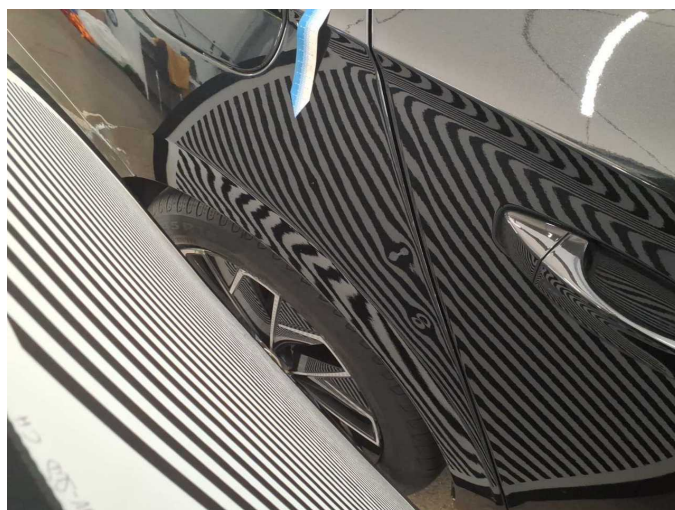
**Accident 1:** Rear, Side right

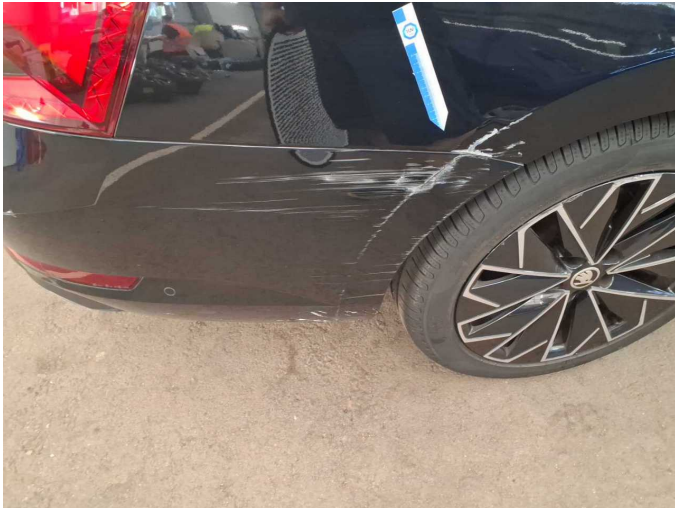
**Accident 1: Rear, Side right**

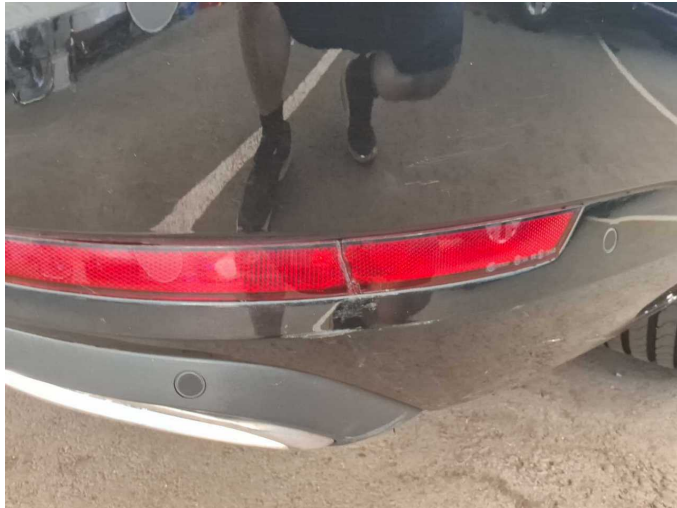
**Accident 1:** Rear, Side right

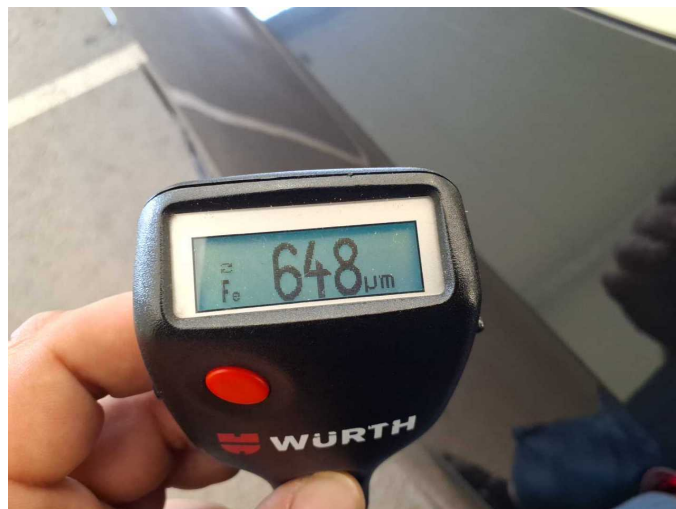
**Repainting 1:** Side panel - rear left side

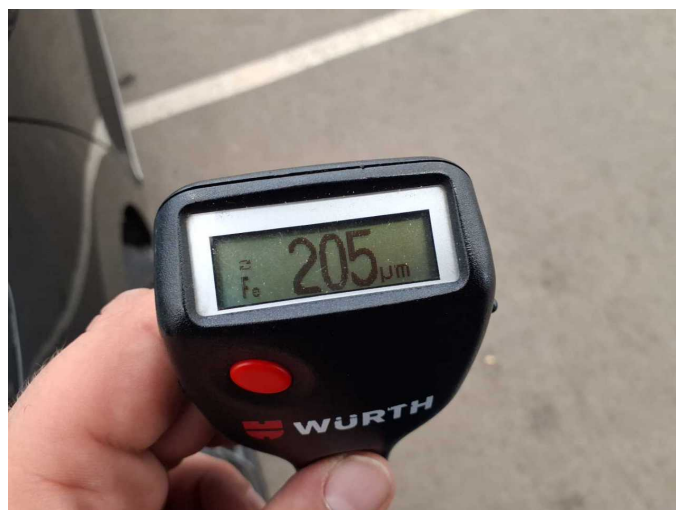
**Repainting 2:** Side panel - rear right side

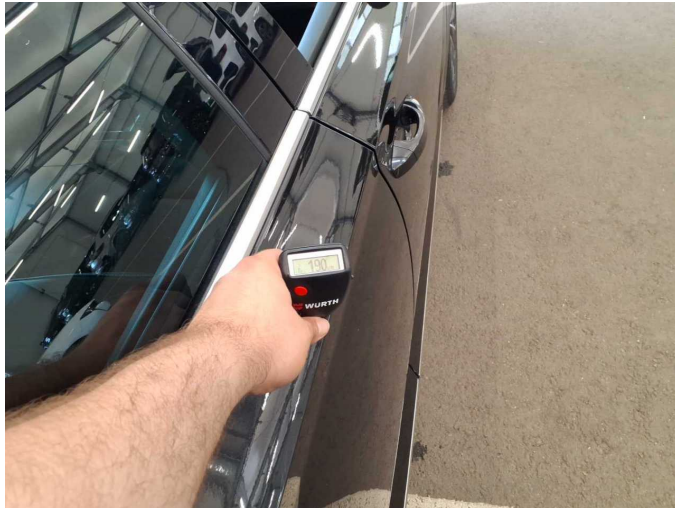
**Repainting 3:** Door - rear left side

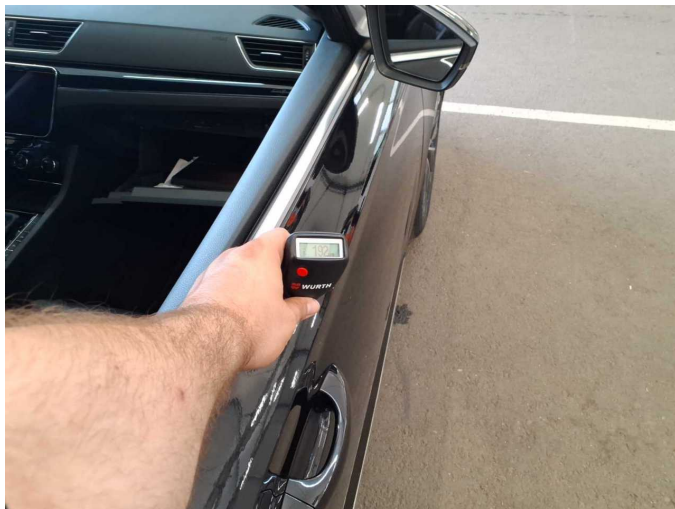
**Repainting 4:** Door - rear right side
