Expertise

Protocol number: 45526603
Order No. / Reference: 26362117
Inspection date: 18 May 2026

Model: Focus Turnier 2.0 EcoBlue Start-Stopp-System Aut. ACTIVE

VIN: WF0PXXGCHPLY71171

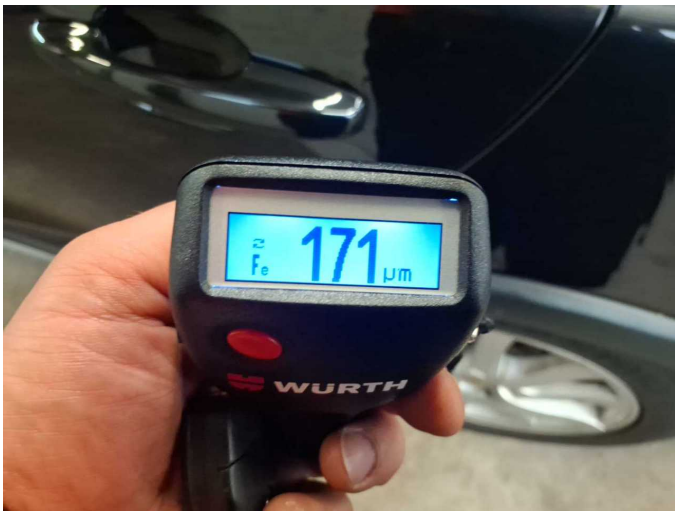
Repainting 1: Side panel - rear left side, Door - rear left side
