Expertise

Protocol number: 45890795
Order No. / Reference: 26389772
Inspection date: 9 Jun 2026

Model: 317 CDI Sprinter Standard HA 9G-Tronic

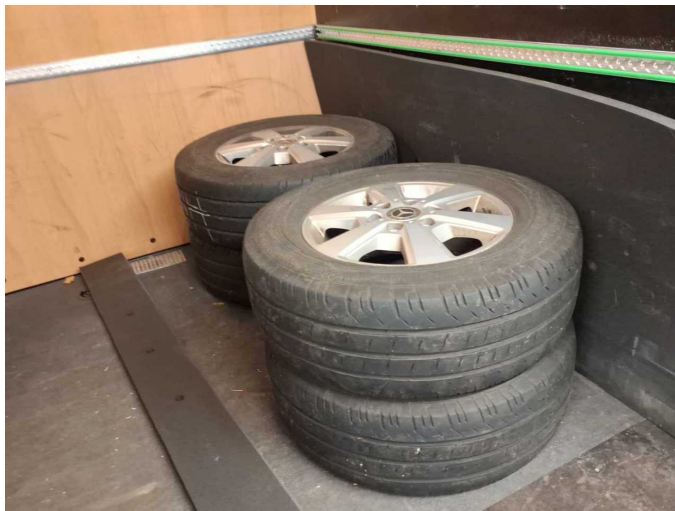
Figure 15: Additional tyres

Der montierte Winterradsatz ist kein Bestandteil der Ausstattung.

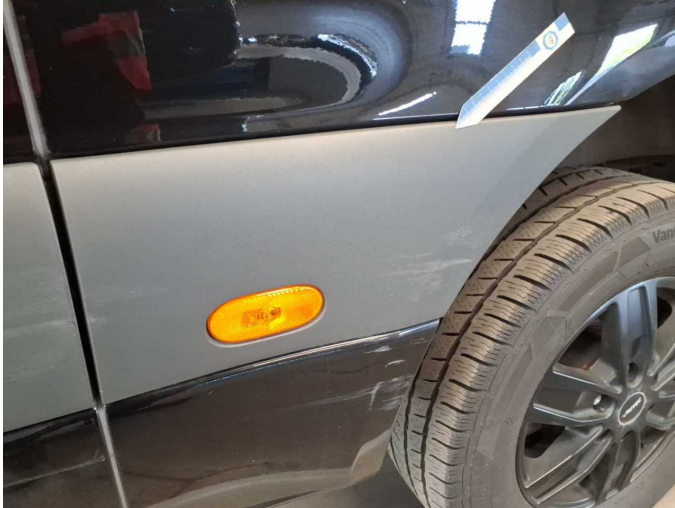
Accident 1: Side - left

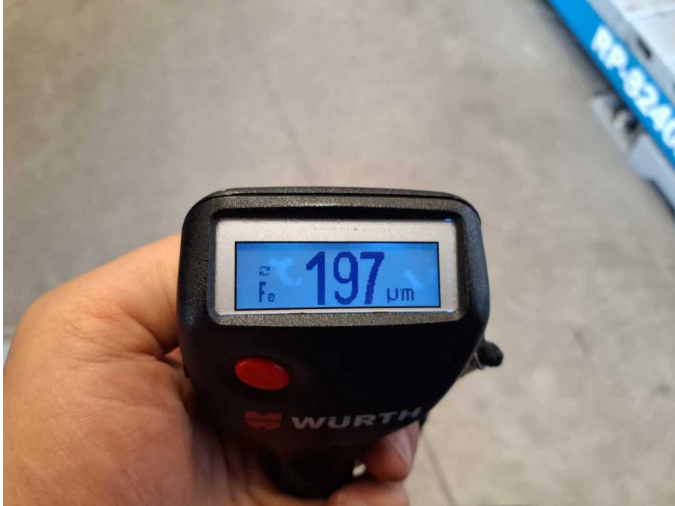
Repainting 1: Mudguard - left side, Mudguard - right side

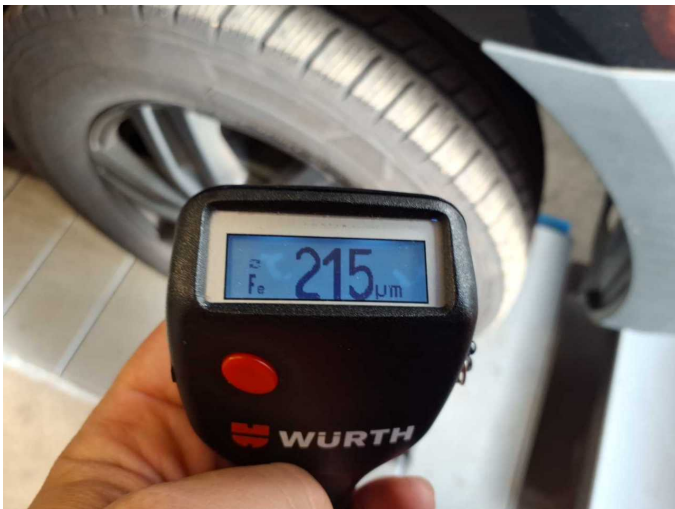
Repainting 1: Mudguard - left side, Mudguard - right side
