Expertise

Protocol number: 46542409  
Order No. / Reference: 26674075  
Inspection date: 15 Jul 2026

| Manufacturer: Opel | Model: Grandland Plug-in-Hybrid 1.6 DI Automatik Business Edition |

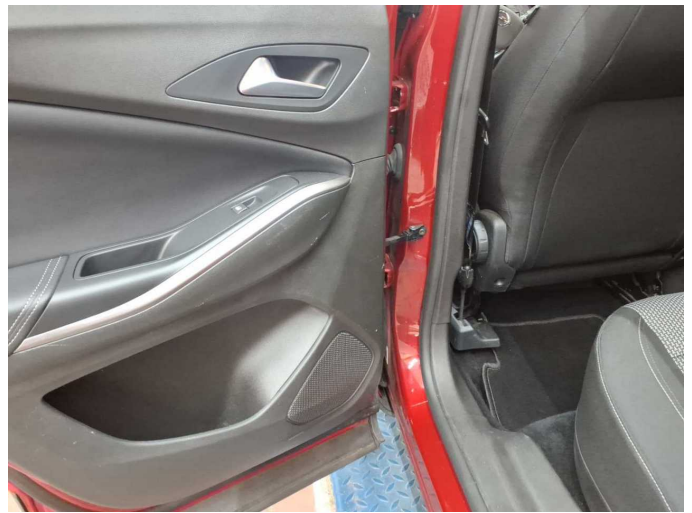
**Damage 2:** Trim / covers: Door trim - rear left side - Scratch(es) - Loss in value
