Expertise

Protocol number: 46322217
Order No. / Reference: 26512570
Inspection date: 3 Jul 2026

Model: Octavia Combi 2.0 TDI DSG Style

VIN: TMBJG0NX6NY056961

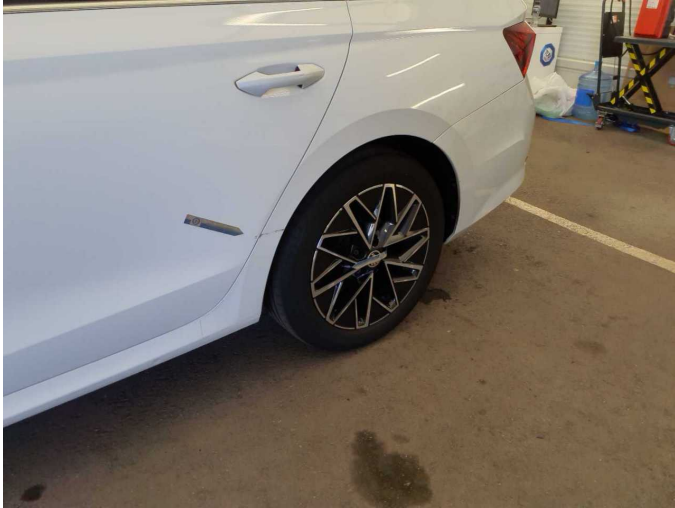
Accident 1: Side - left

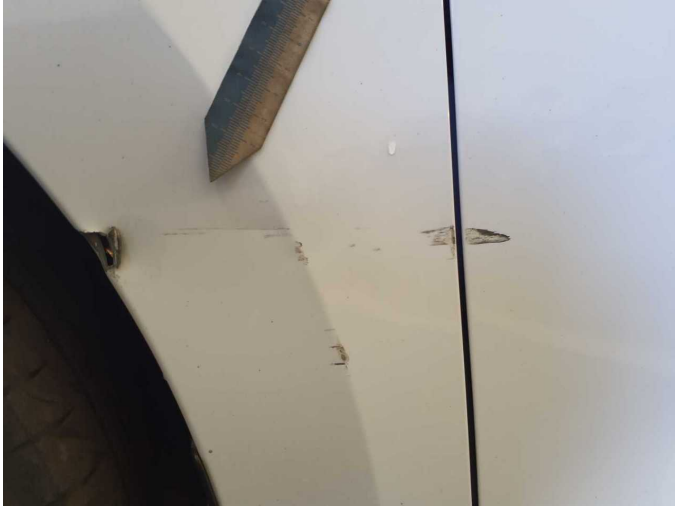
Accident 1: Side - left

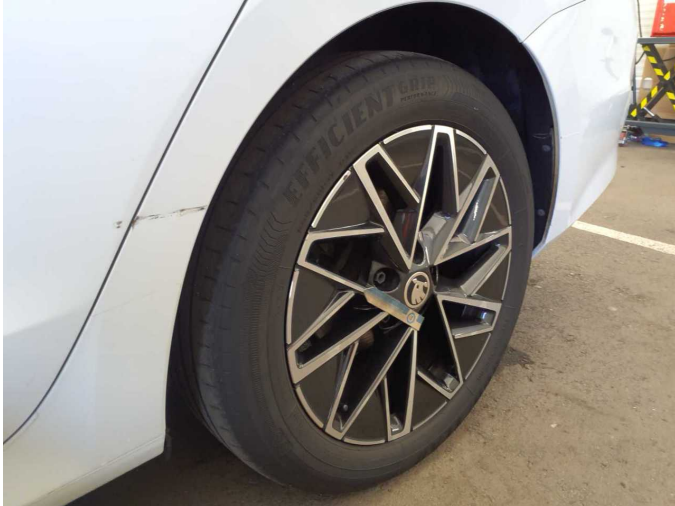
Accident 1: Side - left

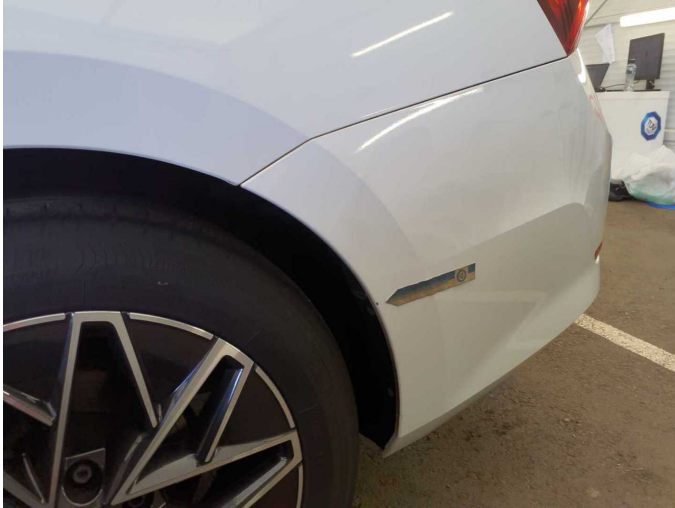
Accident 1: Side - left
