## Expertise

Protocol number: 45992123  
Order No. / Reference: 26359112-1  
Inspection date: 1 Jun 2026

Manufacturer: Renault

Model: Kangoo Rapid Blue dCi 75 Extra

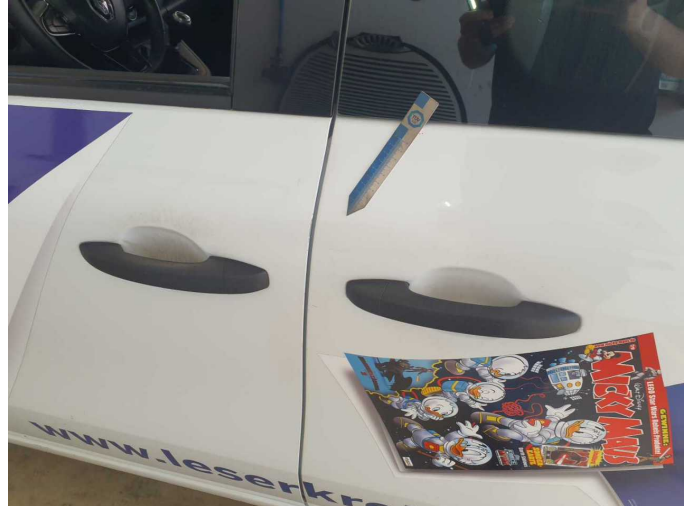
Damage 1: Door - rear left side: Door - Scratch(es) - Smart repair

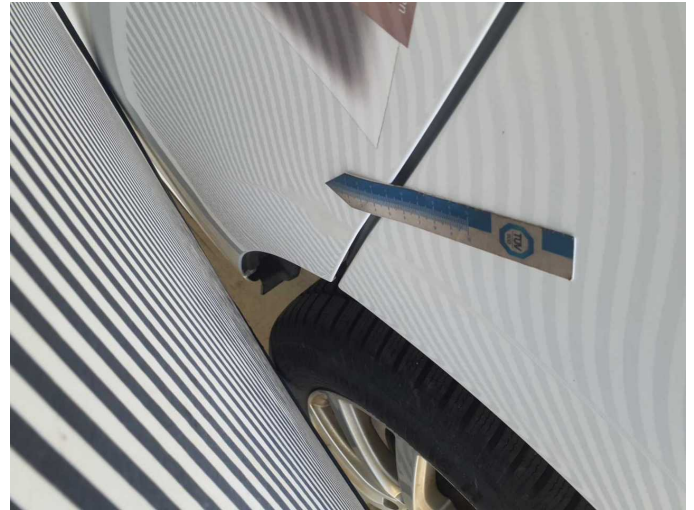
Accident 1: Side - left

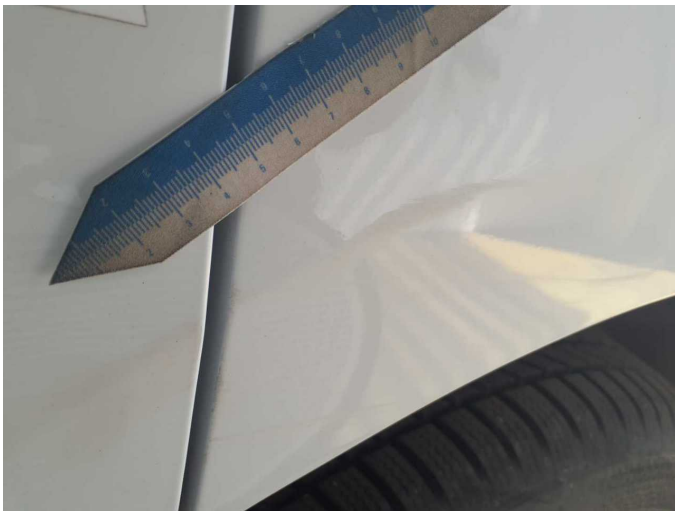
Accident 1: Side - left

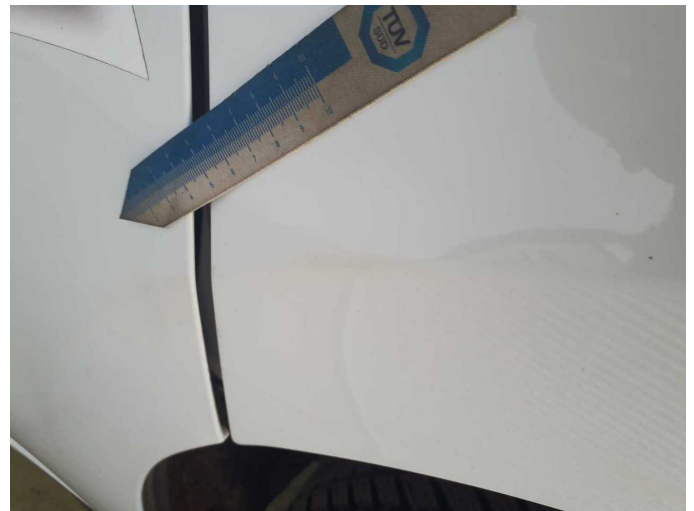
Accident 1: Side - left

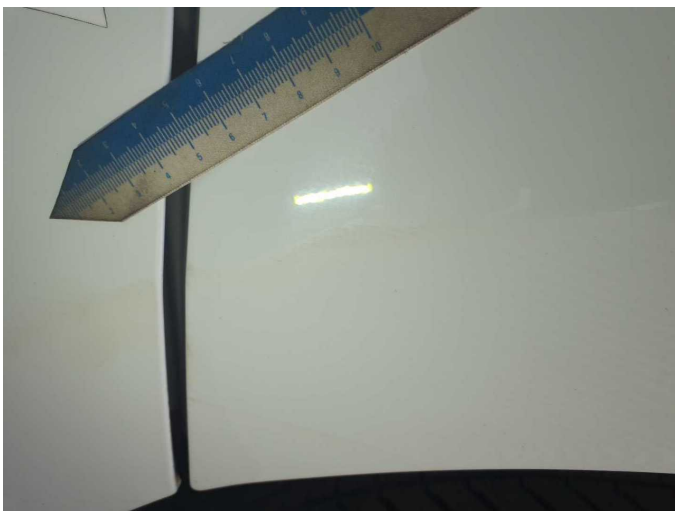
Accident 1: Side - left

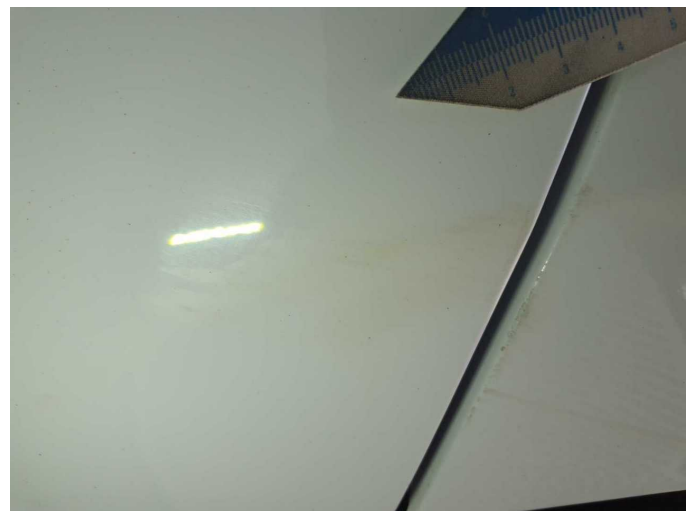
Accident 1: Side - left

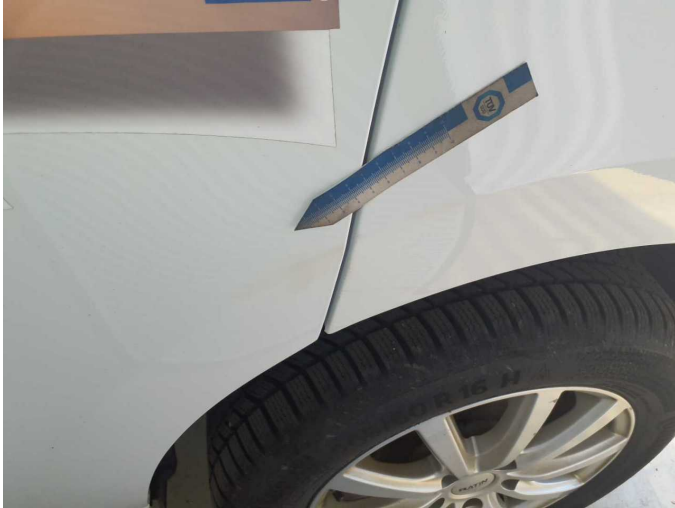
Accident 1: Side - left

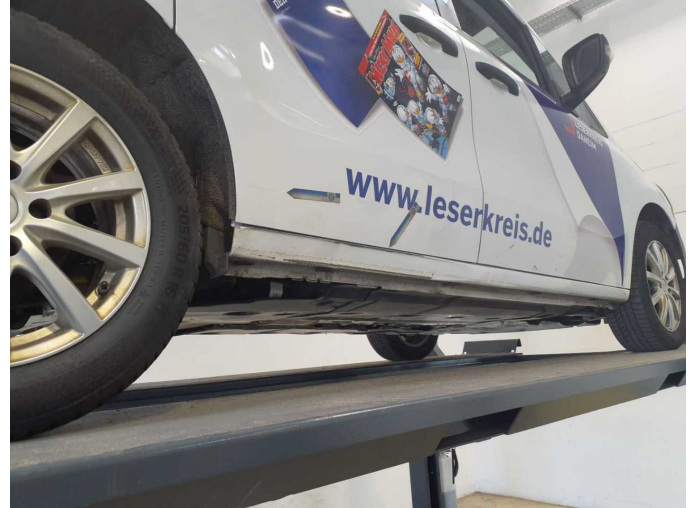
**Accident 1:** Side - left

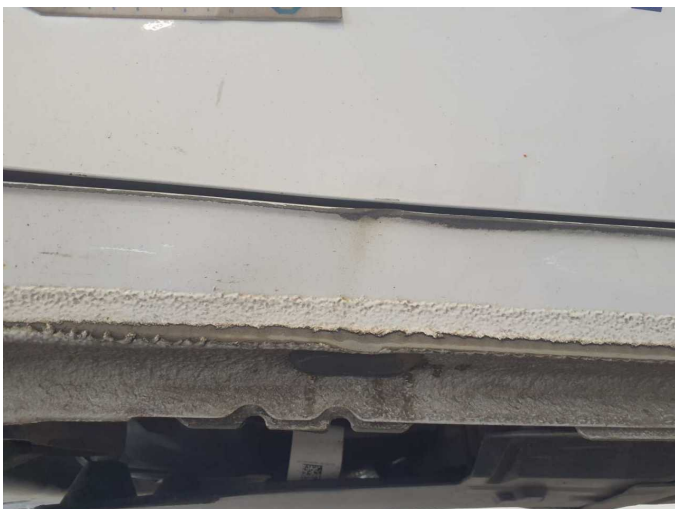
**Accident 2:** Side right

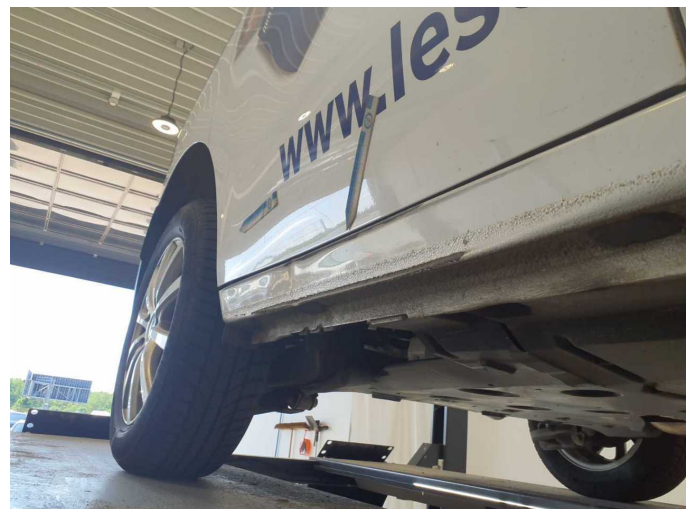
**Accident 2:** Side right

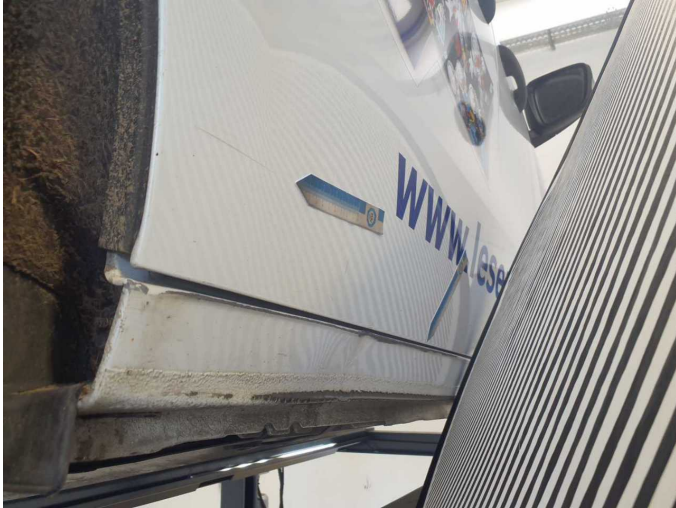
**Accident 2:** Side right

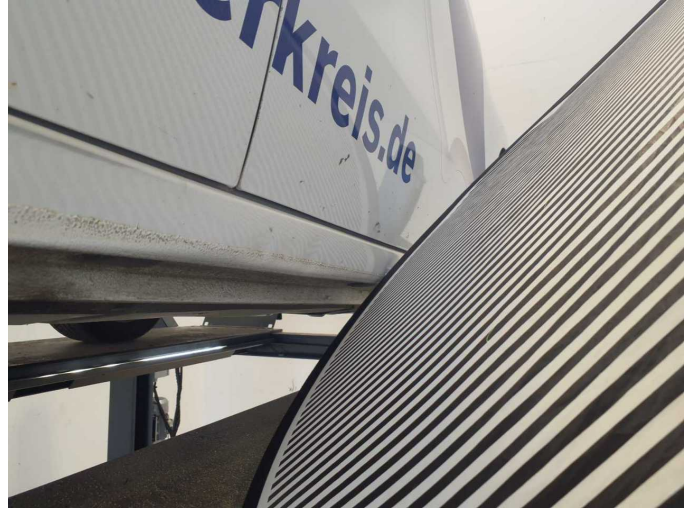
Accident 2: Side right

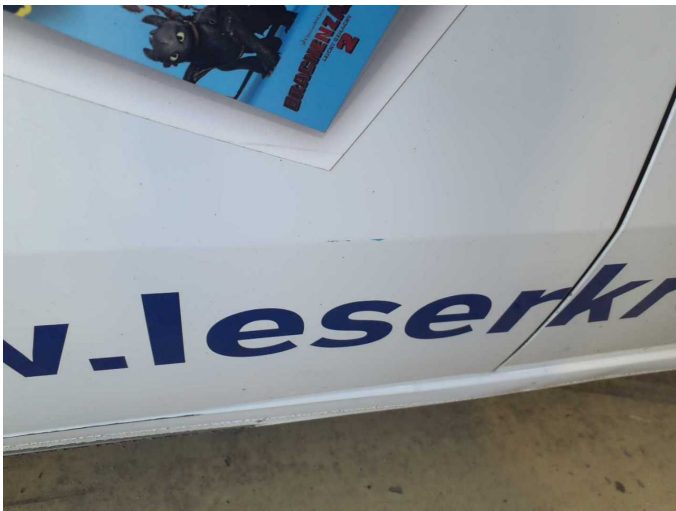
Accident 2: Side right

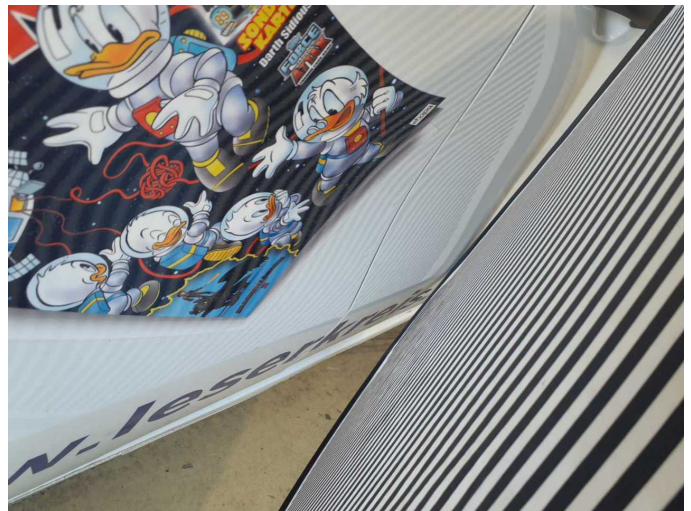
Accident 2: Side right
