Expertise

Protocol number: 45769961
Order No. / Reference: 26479632
Inspection date: 2 Jun 2026

Model: Traveller L2 2.0 BlueHDi 180 EAT8 Business

VIN: VF3VEEHZ8LZ083636

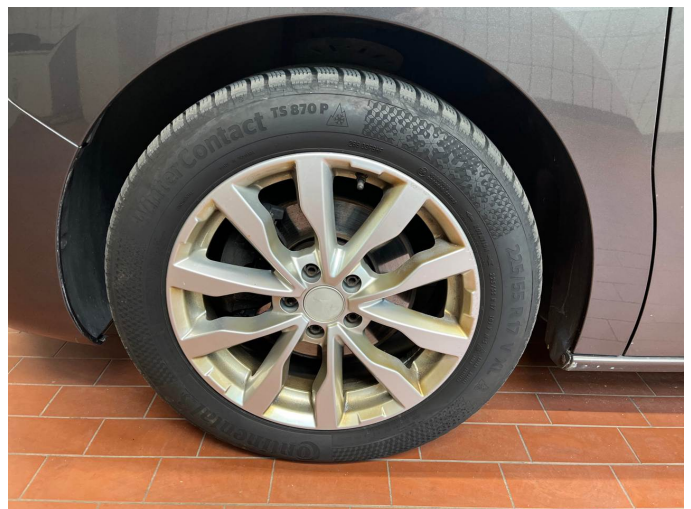
Figure 12: Mounted tyres

Mounted tyres				
#	Tyre size	Type of tyre	Manufacturer	Tread depth
1)	225/55 R17 101V	Winter tyres on Light alloy	Continental	3mm / 3mm
2)	225/55 R17 101V	Winter tyres on Light alloy	Continental	7mm / 7mm
Additional tyres				
#	Tyre size	Type of tyre	Manufacturer	Tread depth
1)	225/55 R17 101Y	Summer tyres on Steel rim with wheel cover	Continental	3mm / 3mm
2)	225/55 R17 101Y	Summer tyres on Steel rim with wheel cover	Continental	5mm / 5mm
Replacement				
Typ	Tyre size	Type of tyre	Manufacturer	Tread depth
	Tirefit	Expiration date 03/2025

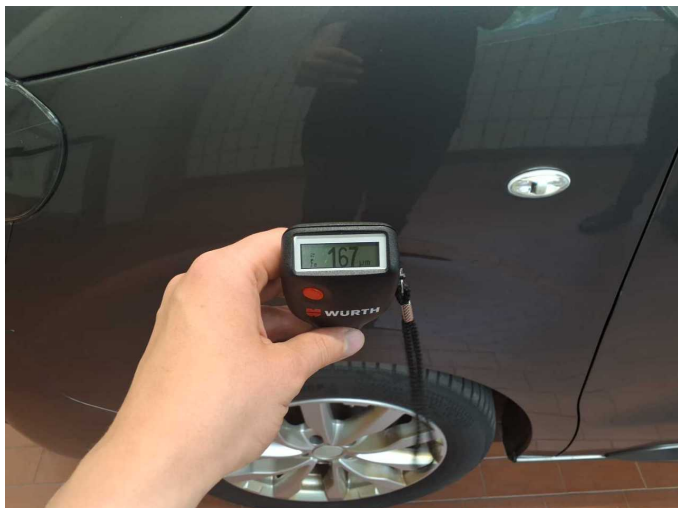
Repainting 2: Mudguard - left side

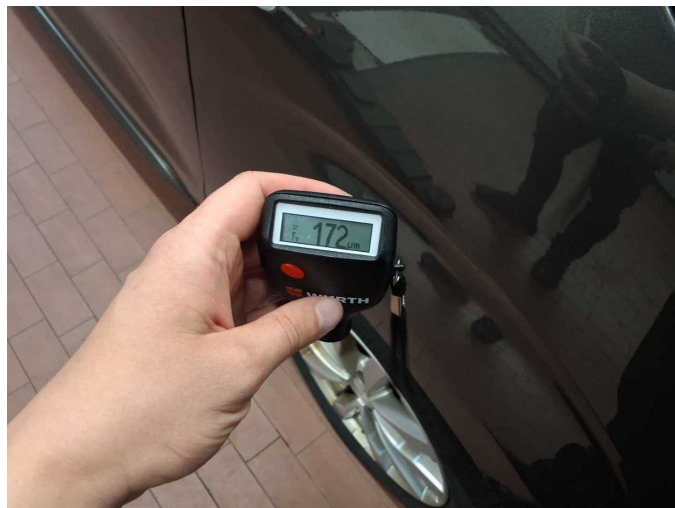
Repainting 3: Mudguard - right side

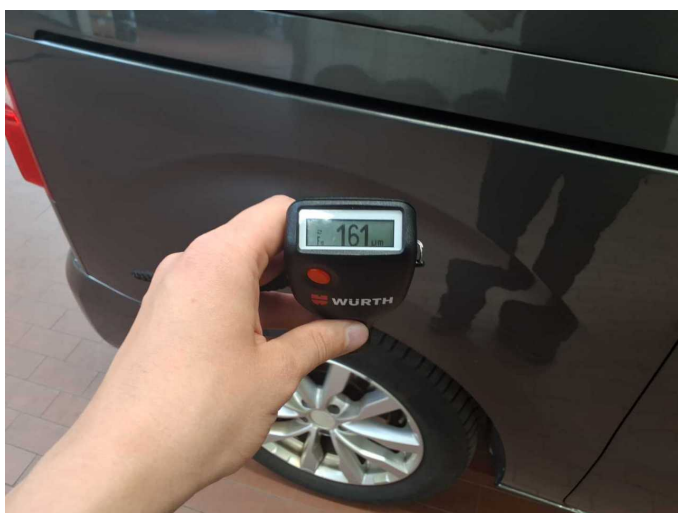
Repainting 4: Side panel - rear right side

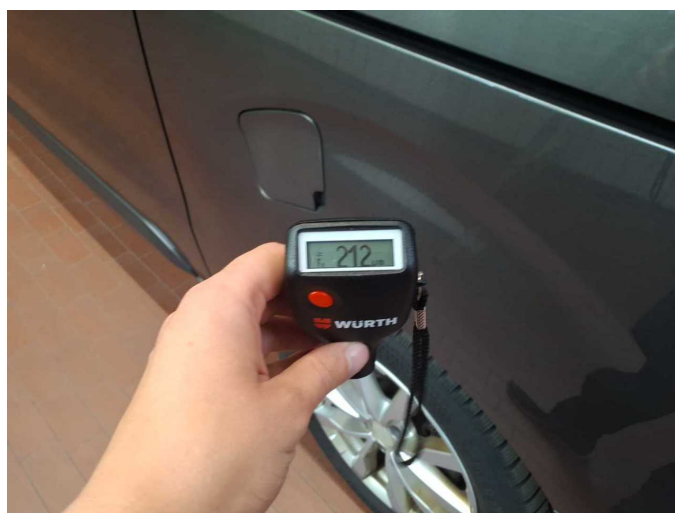
Repainting 5: Side panel - rear left side
